**Ardaman & Associates, Inc.**

May 26, 2021  
File Number 20-13-0068

Subject: 2021 Annual Landfill Inspection under Coal Combustion Residuals (CCR) Rule,  
Stanton Energy Center, Orange County, Florida

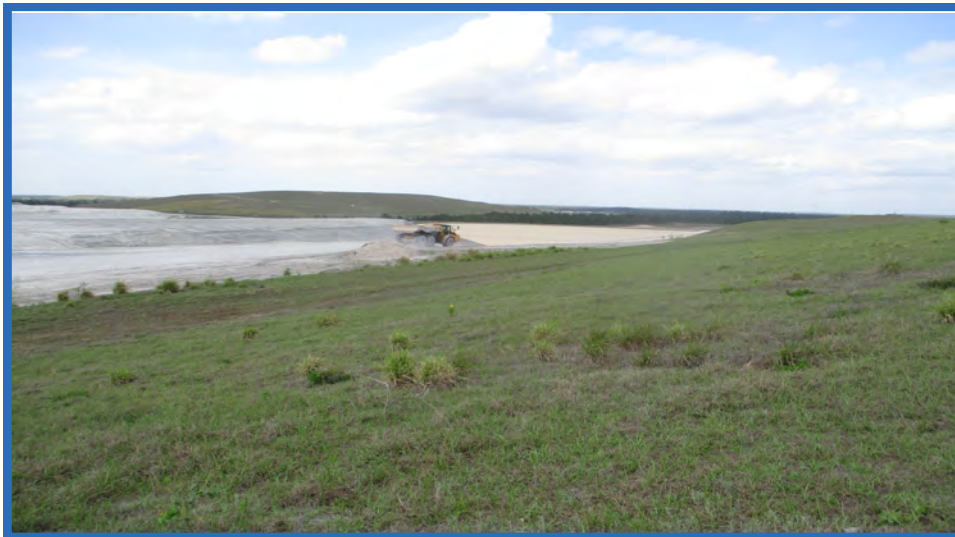
The grass on the west slope of the closed vertical expansion and within the lined slope area of Cell 1, which extends from an elevation of approximately +158 feet (NAVD88) at the toe to an elevation of approximately +175 feet (NAVD88) at the crest, was short enough to allow visual inspection. The soil and grass cover in this area were generally in good conditions. However, there were a few minor bare spots and shallow erosion gullies. These bare spots and erosion gullies do not require any immediate corrective actions, but should be monitored, especially after heavy storm events. If soil erosion occurs in the bare spots or the shallow erosion gullies become wider or deeper, corrective measures should be implemented as part of routine landfill maintenance activities. The reverse bench at the base of the closed vertical expansion was also in a good condition and should be able to intercept non-contact stormwater runoff from the closed slope of the vertical expansion above the bench before it runs onto the Cell 1.

Reverse Bench and Western Slope of Closed Original CWSA  
Looking Northwest

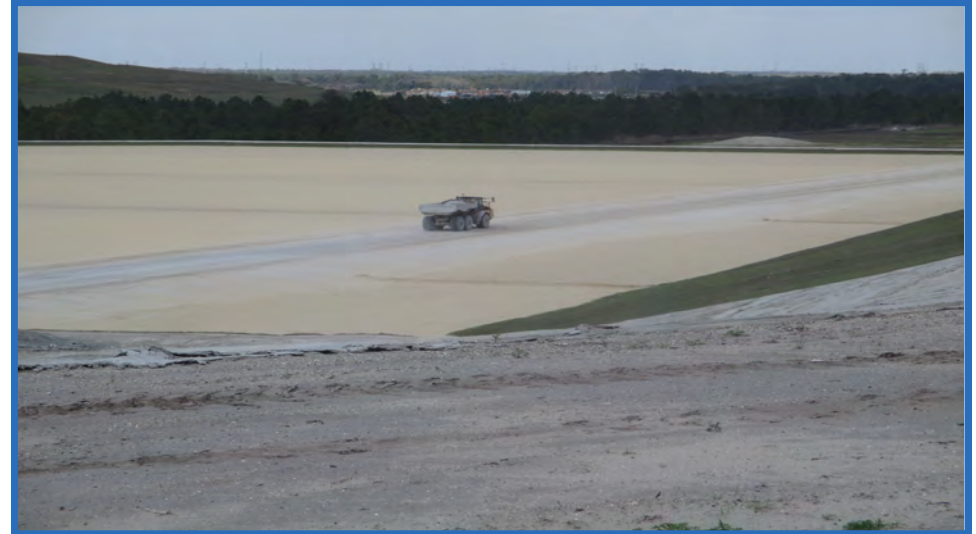
Both the East and West Haul Roads were in good conditions, with minimal rutting, depression, and water puddles. The roads were approximately 50 feet wide, which should be sufficient for

West Haul Road through Cell 2  
Looking Northwest

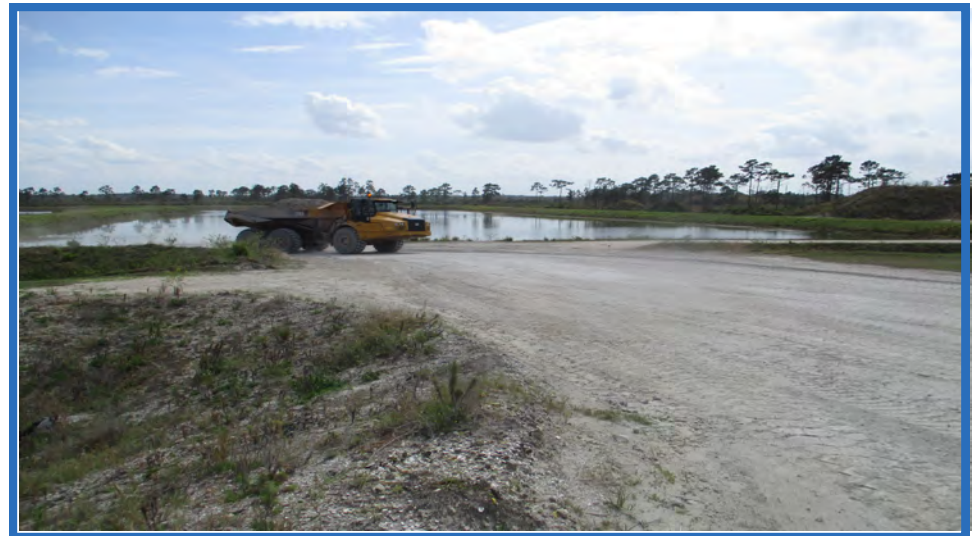
Articulated Dump Truck Hauling Waste through East Haul Road for Placement in Cell 1

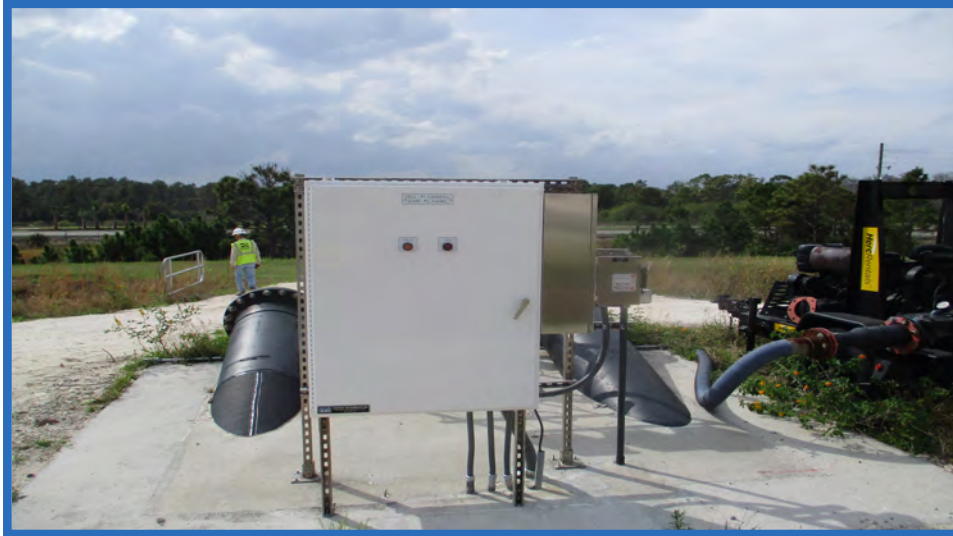
The leachate pumping system and associated control panels had not been fully functional at the time of the inspection. It was observed that new control panels and the pumping system had been installed. Two skid-mounted auxiliary pumps were placed on the crest road of the west containment dike, with the intake placed inside Cell 1 on the west side. The auxiliary pump was not operating at the time of our site visit. There was no standing water above the sump areas in Cell 1, but some isolated shallow water puddles were observed.

Replaced Control Panel and Pump Station for Sump 2

- The original leachate pumping system for Cell 1 is being replaced with a new system as part of the Cell 2 construction.

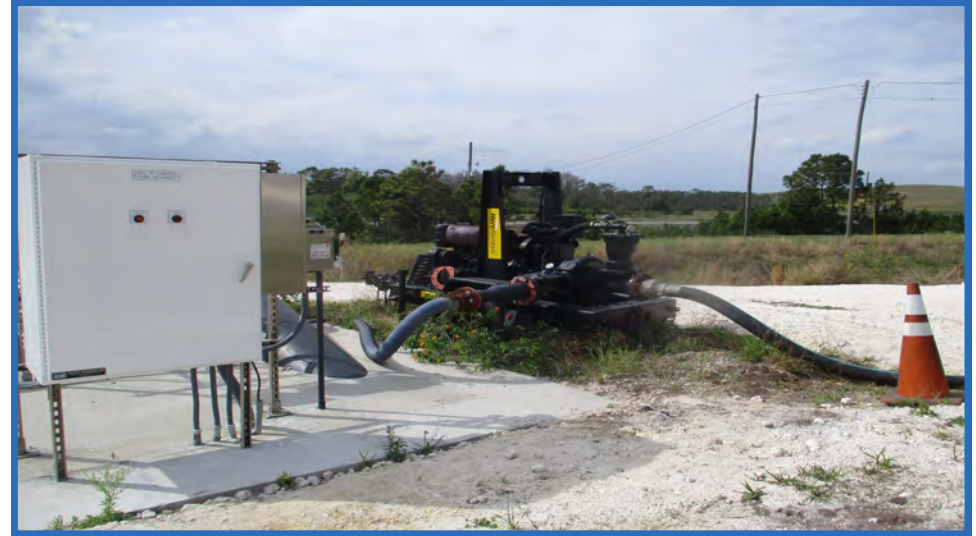
Auxiliary Pump Deployed at Sump 2 to Pump  
Station Discharge Piping

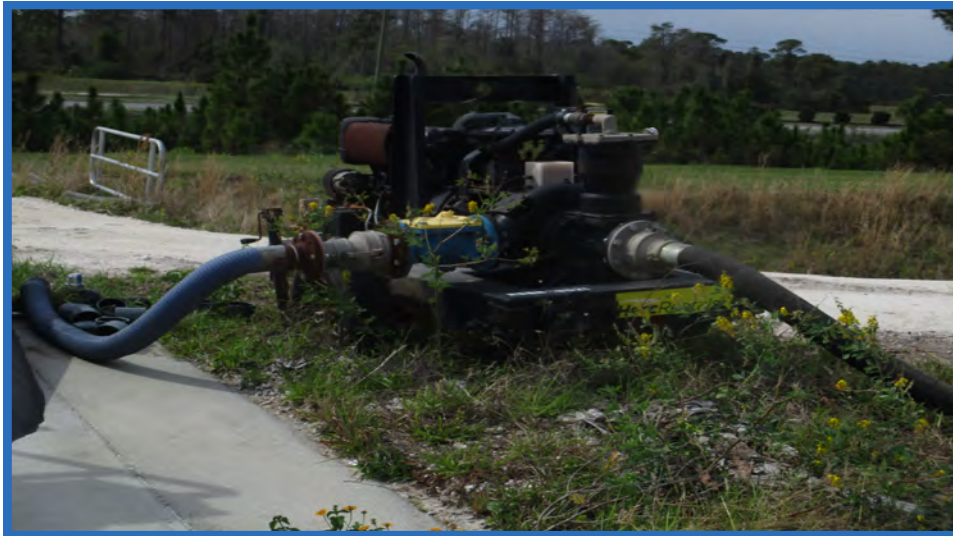
Auxiliary Pump Deployed at Sump 3

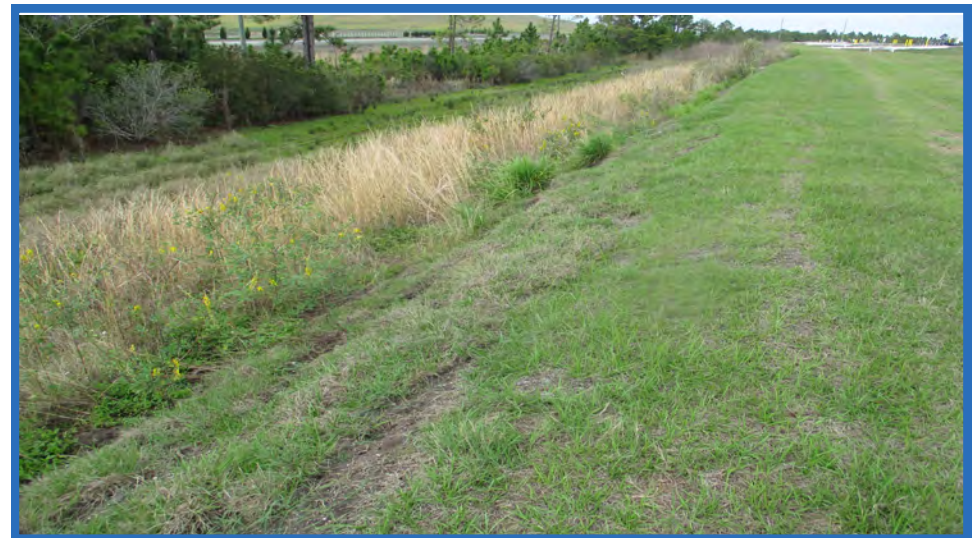
The outside slope of the containment dike, and the inside and outside slopes of the perimeter dike, were generally in good conditions except for some areas with sparse grass cover. Although we did not observe any significant erosion gullies on the dike slopes at this time, OUC should continue to monitor the dike slopes and, if erosion is observed, should repair and then sod or seed the bare areas.

Cell 1 Perimeter Dike  
Looking North

- As part of routine landfill maintenance activities, bare spots should be sodded or seeded to minimize erosion, and erosion gullies should be repaired and then sodded or seeded.

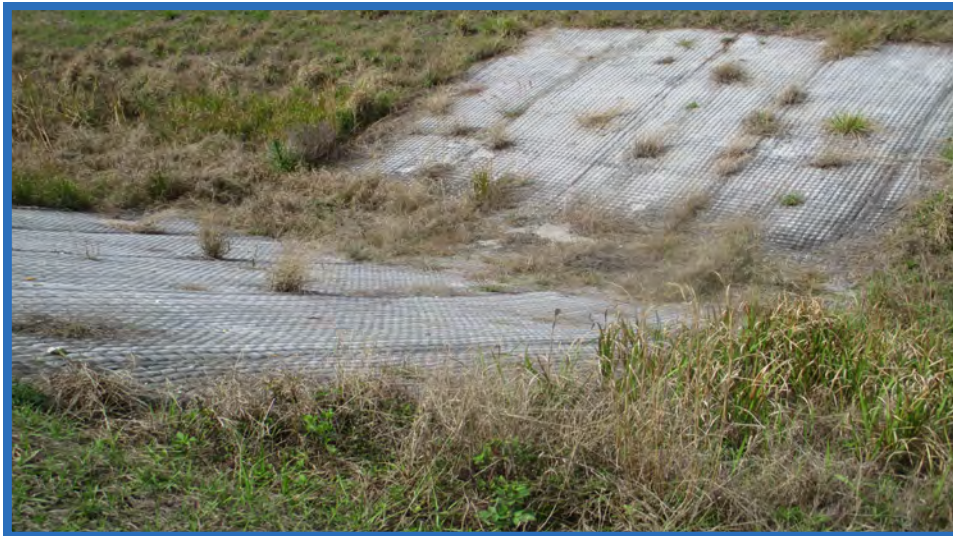
The two inlet structures on the south side of Cell 1, which are connected to pipes draining into the wet detention pond near its northwestern corner, were in good conditions. Uninterrupted water flow was observed in the drainage ditch and through the inlet structures at the time of our site visit.

**Fabriform with Inlets Connected to Pipes Discharging to Wet Detention Pond, Looking Northwest**

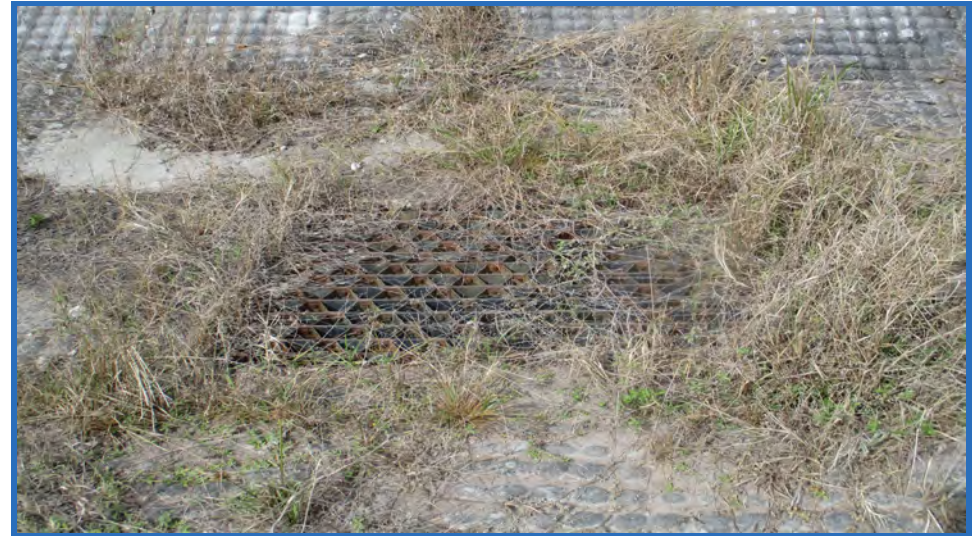
**Inlet Box Connected to Pipes Discharging to Wet Detention Pond**

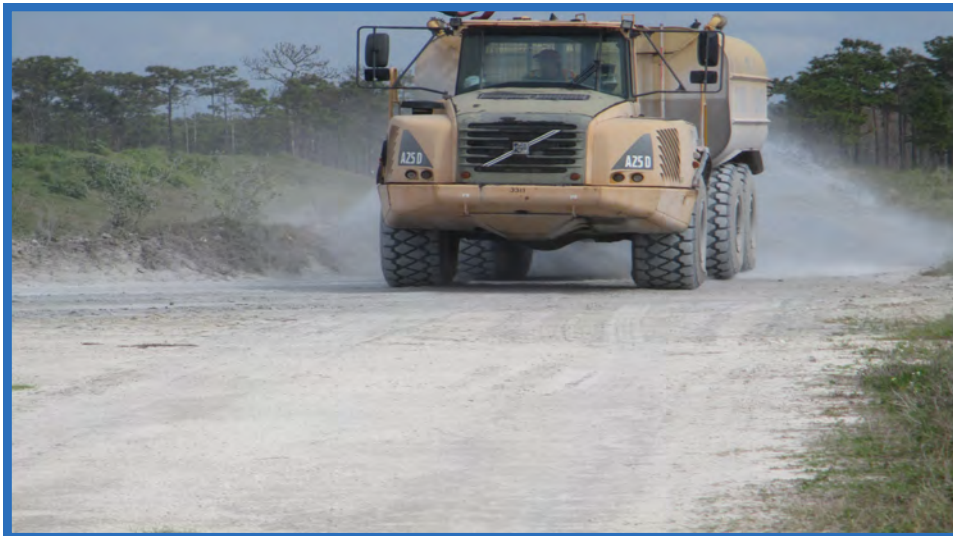
**Dust Control Measure**

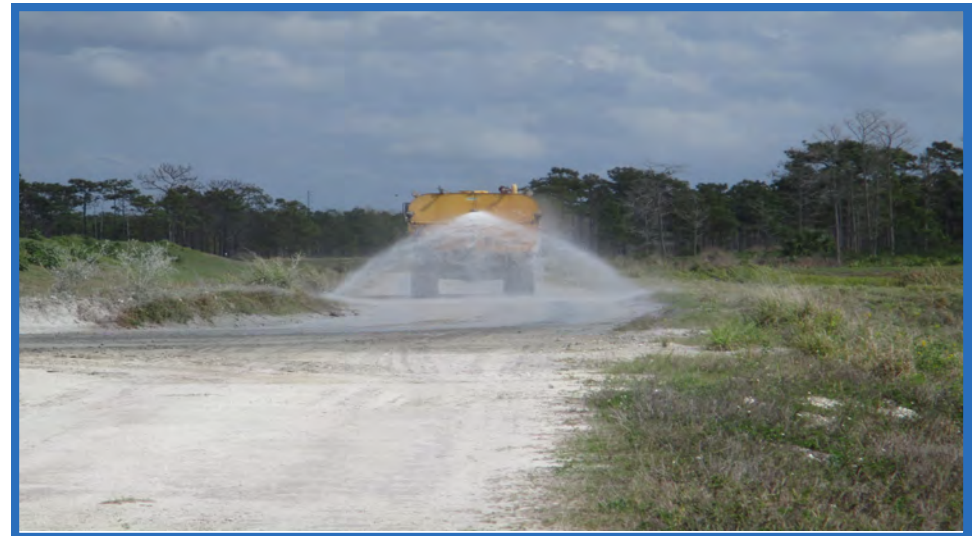
**Dust Control Measure along East Haul Road  
Looking East**

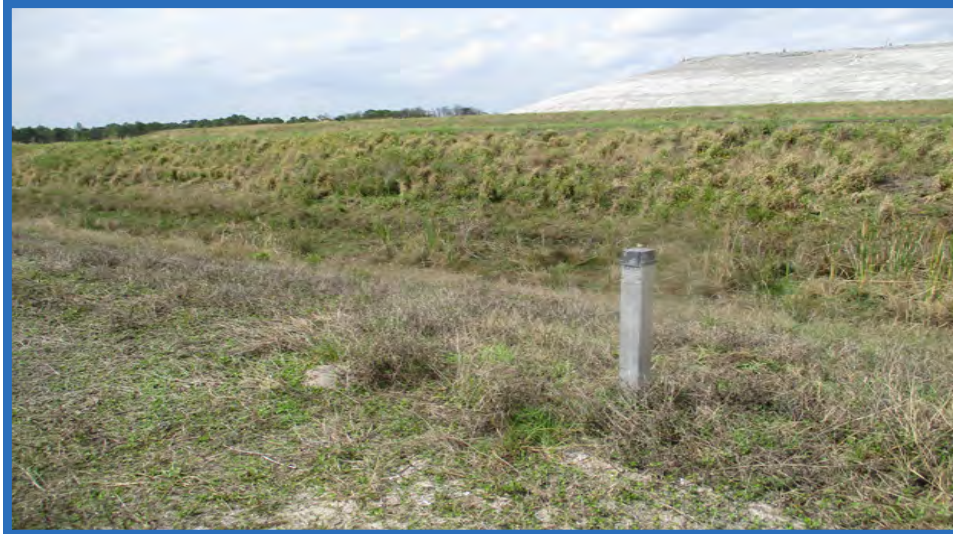
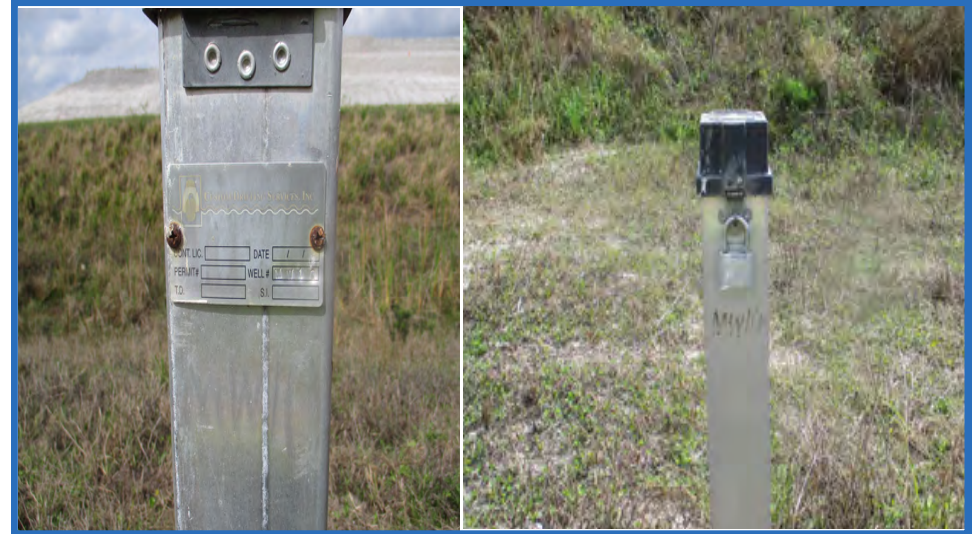
During our site inspection on March 2, 2021, TT-AAI observed three groundwater monitoring wells near Cell 1. These three monitoring wells are designated MW-A, MW-8, and MW-10. Each of these monitoring wells was provided with a concrete pad and a metal protective casing. MW-A is located outside the southeastern corner of Cell 1. MW-10 is located south of Cell 1, and MW-8 is located near the southwestern corner of Cell 1. All three monitoring wells appeared to be in good conditions.

Monitoring Well MW-10
