**2023 Annual Landfill Inspection under  
Coal Combustion Residuals Rule  
Stanton Energy Center  
Orange County, Florida**

May 26, 2023  
Updated July 31, 2023

Subject: 2023 Annual Landfill Inspection under Coal Combustion Residuals (CCR) Rule,  
Stanton Energy Center, Orange County, Florida

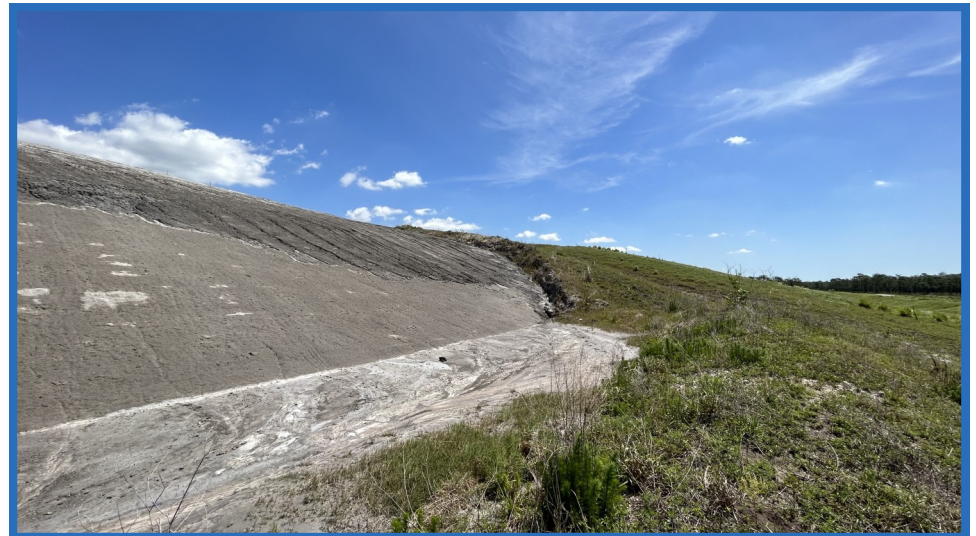
Along the southern boundary of the slope area of Cell 1 that adjoins the closed original CWSA, all waste materials were inside the lined area. However, waste materials were observed above the liner anchor trench on the inside slope of the containment dike along the south and west sides of Cell 1 during our landfill inspection on May 2, 2023, but the issue was confirmed to have been properly rectified before our follow-up site visit on May 31, 2023. During our follow-up site visit, the landfill slope near the toe along the south and west sides of Cell 1 was observed to be slightly steeper than the rest of the slope. Although the slightly steeper slopes near the toe should not affect landfill stability, the landfill slope should be surveyed and reviewed prior to closure.

Southern Slope of Waste Mound, in Cell 1 Where It Abuts  
Closed Original CWSA, Looking Northeast

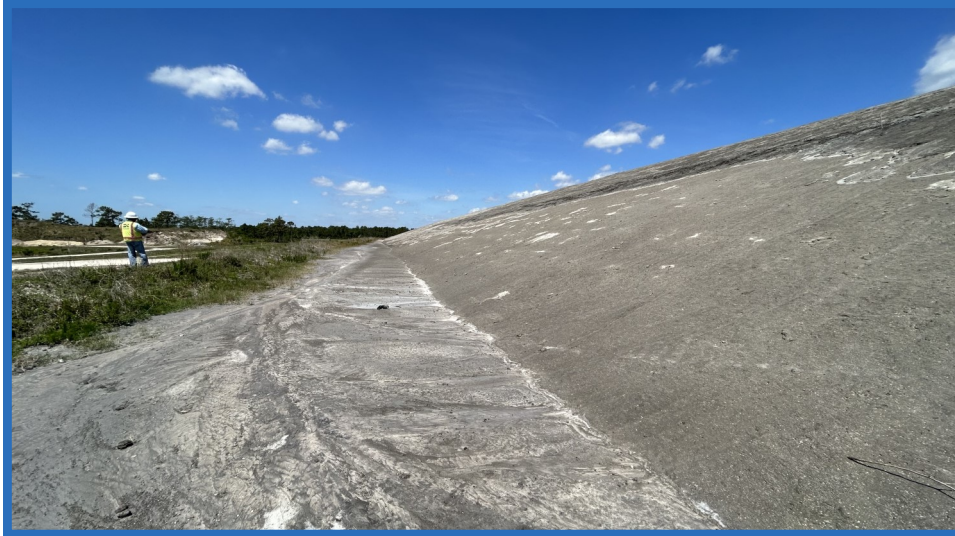
**Southern Slope of Waste Mound in Cell 1, Looking South**

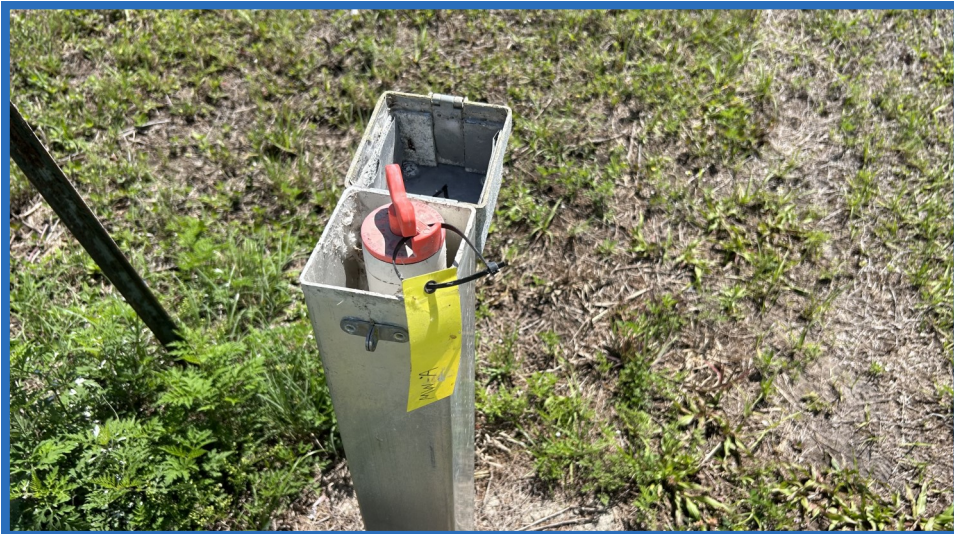
During our site inspection on May 2, 2023, TT-AAI observed three groundwater monitoring or water level observation wells near Cell 1. These three wells are designated MW-A, MW-9R, and MW-10. Each of these wells was provided with a concrete pad and a metal protective casing. MW-A is located near the southeastern corner of Cell 1. MW-10 is located south of Cell 1 and near the northwestern corner of the wet detention pond. MW-9R is located west of and near the southwestern corner of Cell 1. All three wells appeared to be in good conditions without any visible damages. However, the metal tag and handwritten designation for the well located west of and near the southwestern corner of Cell 1, which we believe to be MW-9R, should be checked and, if necessary, properly labeled. Also, some of the wells were not locked.

Monitoring Well MW-A on Southern Side of Cell 1

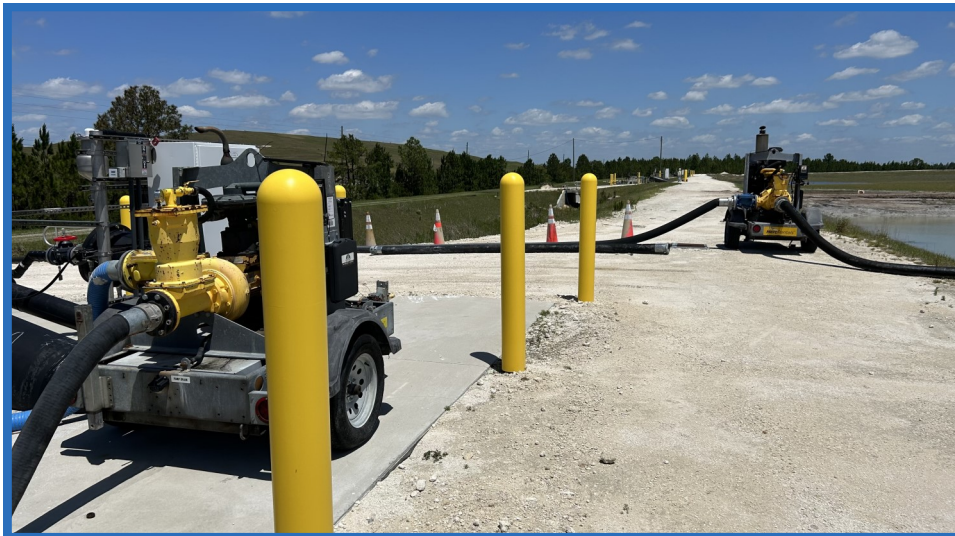
- Except for the transformer for the Cell 2 leachate collection and leak detection system tripping, as noted in the January 3, 2022 inspection report, all pumps in Cells 1 and 2 were reported as operating in "Auto" mode through the week of April 25, 2022. In the March 3, 2007 inspection report, it was noted that, although all leachate collection pumps appeared to be operating, diesel auxiliary pumps had to be used because of high water levels in Cell 1.

Diesel Auxiliary Pumps with Intakes Deployed in Cell 2

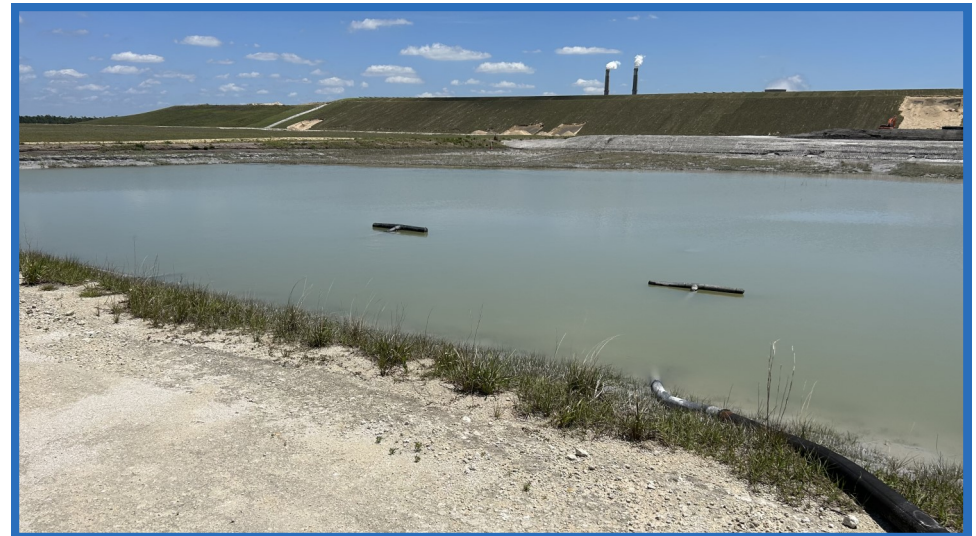
Intakes for Auxiliary Pumps in Preceding Photograph Deployed in Cell 2

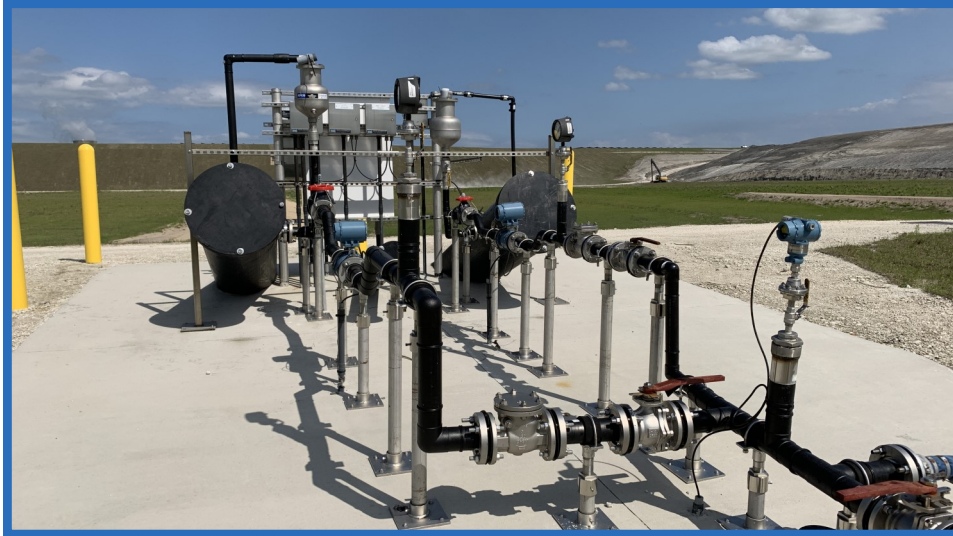
- After April 25 2022, numerous alarms (high temperature, low temperature, low level, etc.) for the leachate collection and leak detection system were noted. Also, the pumps for Sump 1 in Cell 1 and Sump 1 in Cell 2 were frequently turned off or out of service. The observations were caused by a lightning event or components failure, which required the pumps for these sumps be placed out-of-service until replacement parts could be procured and installed.

Leachate Pump Station for Cell 2, Looking East

- The causes of the blinking alarm/warning lights on all leachate control panels for Cells 1 and 2 should be identified, and any required repairs to the panels and/or equipment should be performed as soon as possible. We understand that system maintenance is on-going and replacement parts for the failed components have been ordered by OUC.

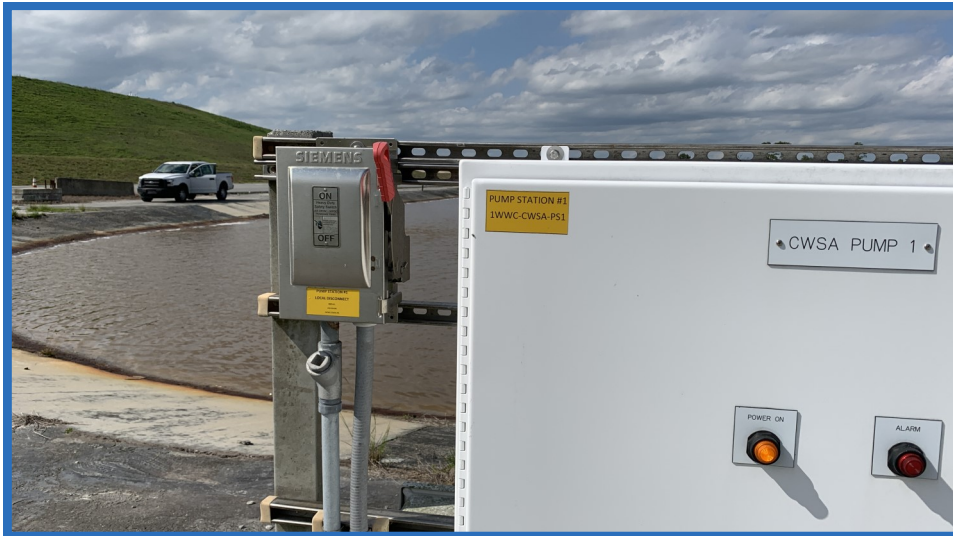
- Numerous alarms and UPS faults were reported for the CWSA Runoff Pond groundwater removal and leak detection pump stations. Leak detection system pump P2 was noted as out-of-service because of a bad motor in the May 23 and June 13, 2022 inspection reports. We understand that replacement parts have been ordered by OUC.

Control Panel for CWSA Runoff Pond Pump 1

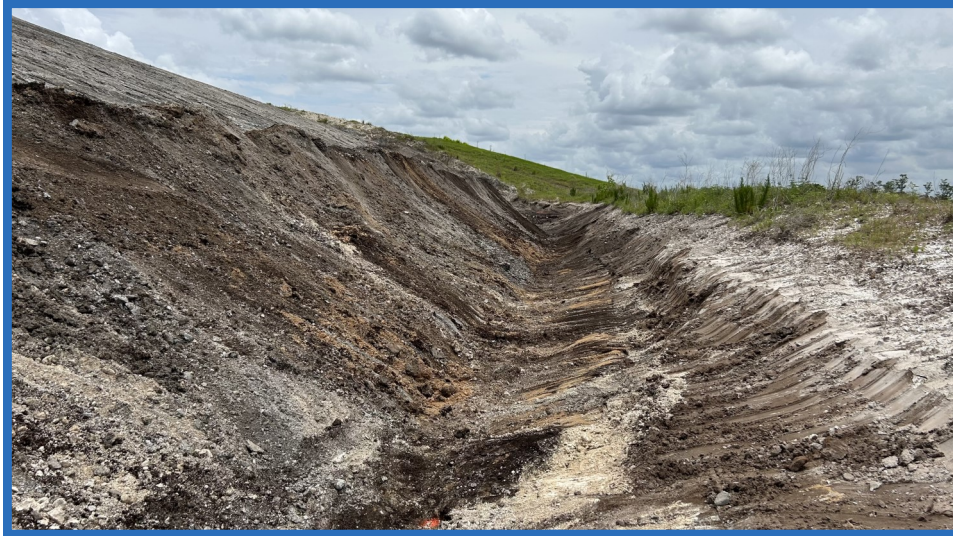
Re-graded Waste on South Side of Cell 1, Looking East

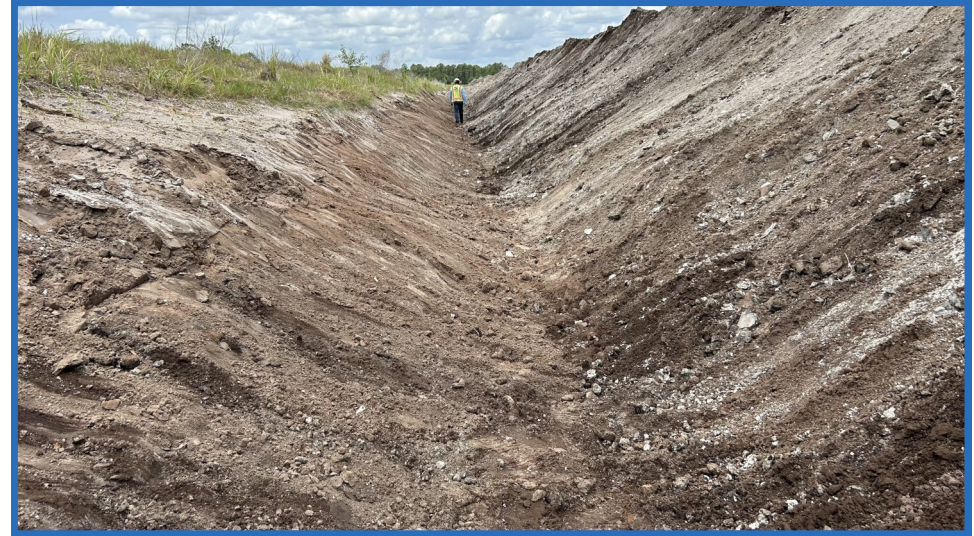
Re-graded Waste on South Side of Cell 1, Looking West

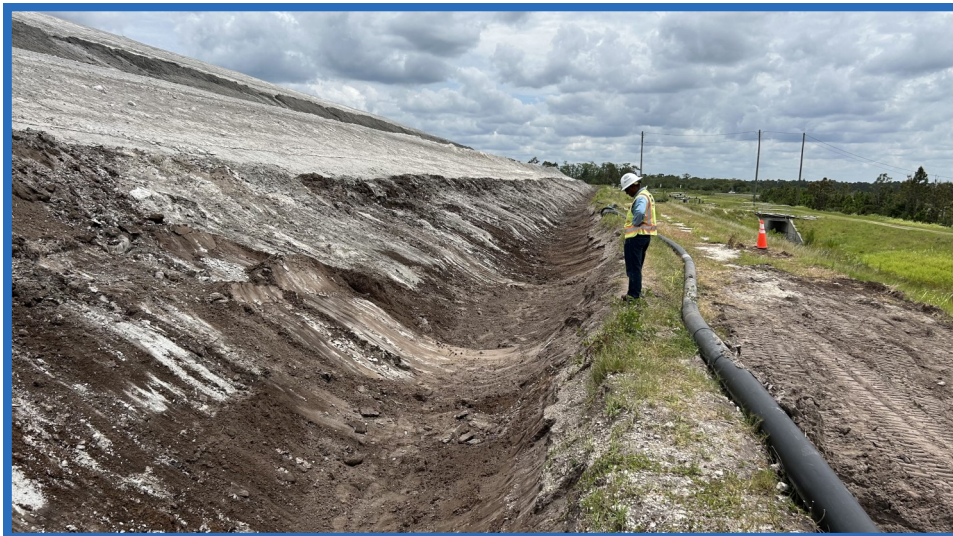
Re-graded Waste on West Side of Cell 1, Looking South

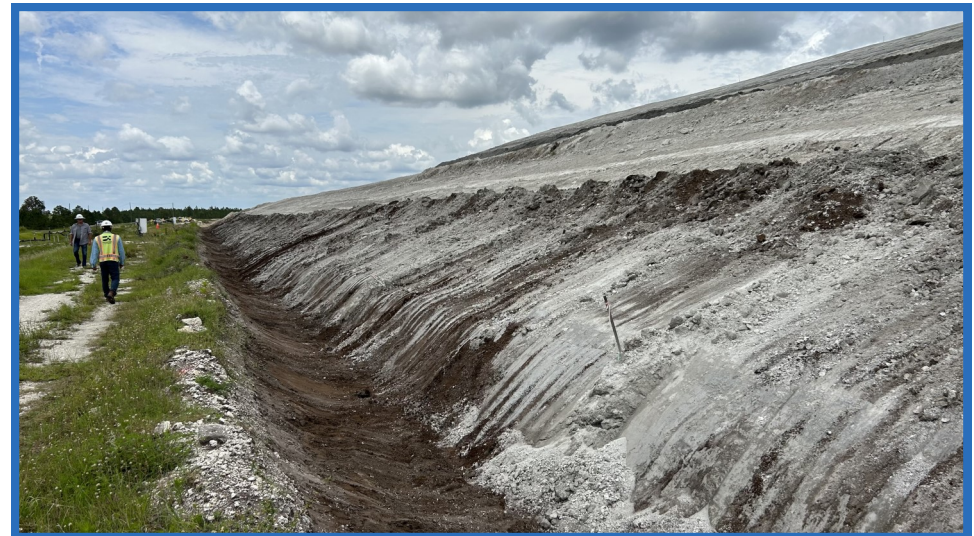
Re-graded Waste on West Side of Cell 1, Looking North
