**2024 Annual inspection Under  
Coal Combustion Residuals Rule  
Orlando Utilities Commission  
Stanton Energy Center  
Orange County, Florida**

May 24, 2024

Subject: 2024 Annual Landfill Inspection under Coal Combustion Residuals (CCR) Rule,  
Stanton Energy Center, Orange County, Florida

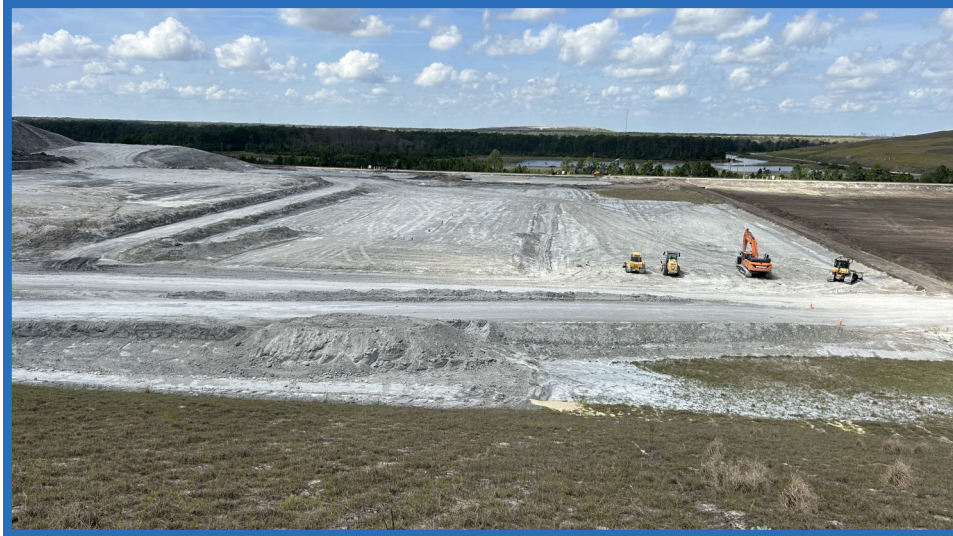
Waste Placed in Cell 2 and Northern Slope of Waste Mound in Cell 1, Looking West from Reverse Bench of Closed Vertical Expansion of Original CWSA

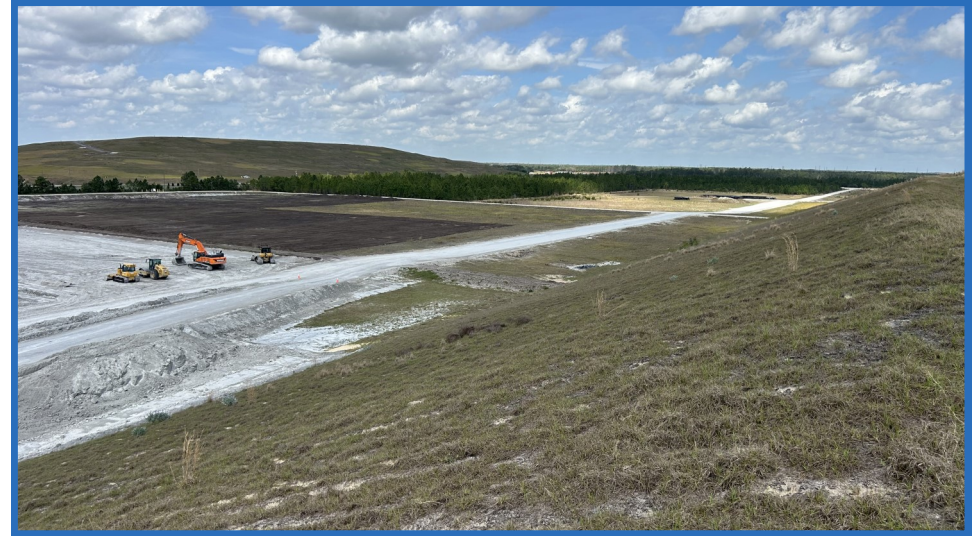
Cell 2, Looking Northwest from Reverse Bench of Closed Vertical Expansion of Original CWSA

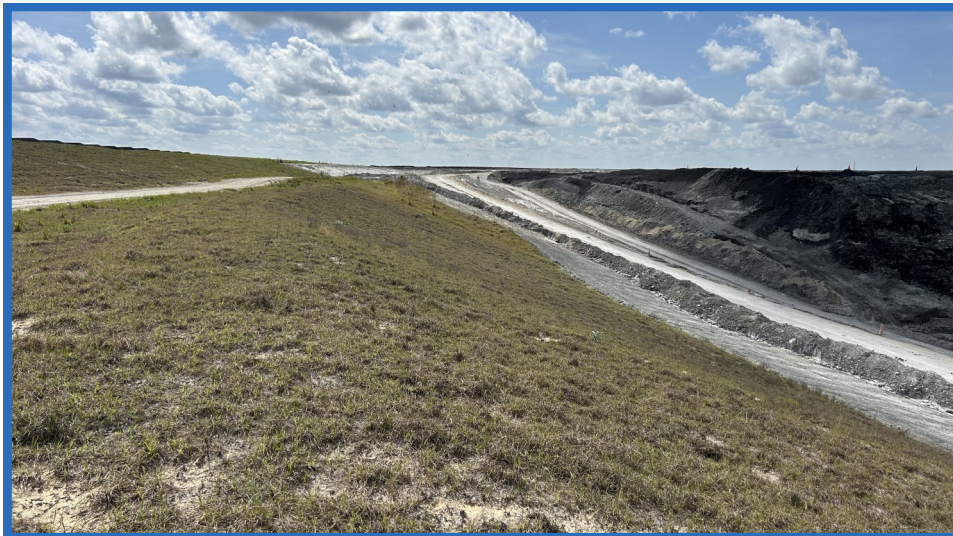
Junction of Waste Mound in Cell 1 with Cell 2 and Reverse Bench of Closed Vertical Expansion of Original CWSA, Looking Southeast

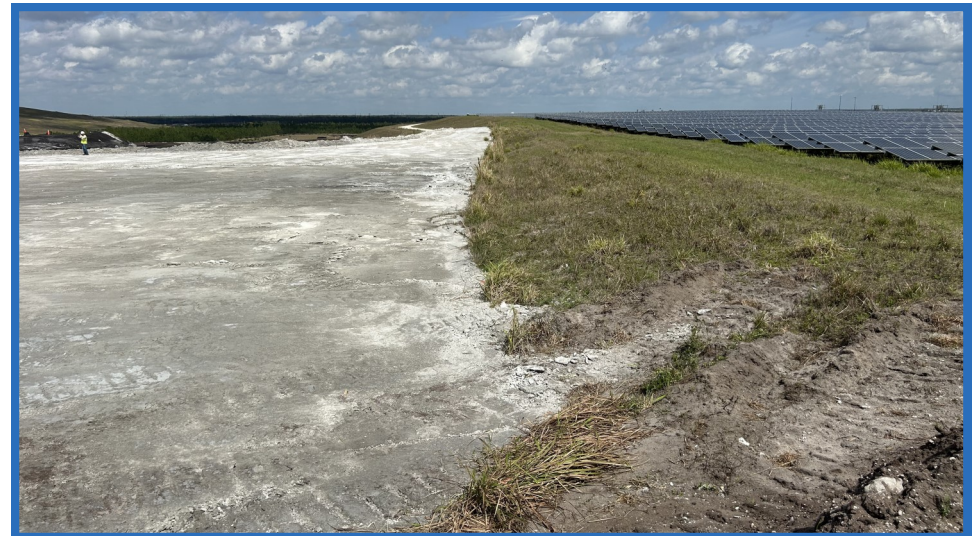
Top of Waste in Cell 1 and Photovoltaic Solar Panels on Top of Closed Vertical Expansion of Original CWSA, Looking Northeast

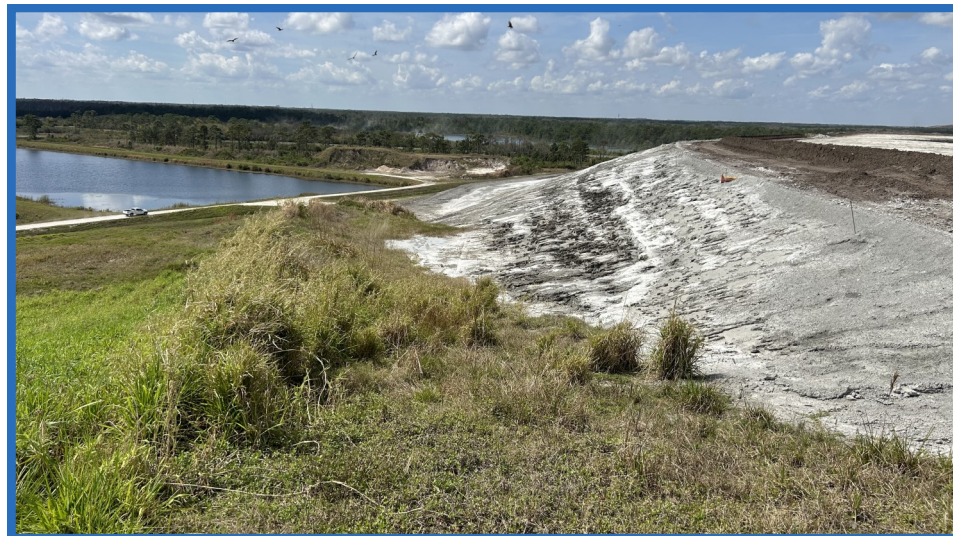
Wet Detention Pond, Looking Southwest from Bench  
at Juncture with Closed Original CWSA

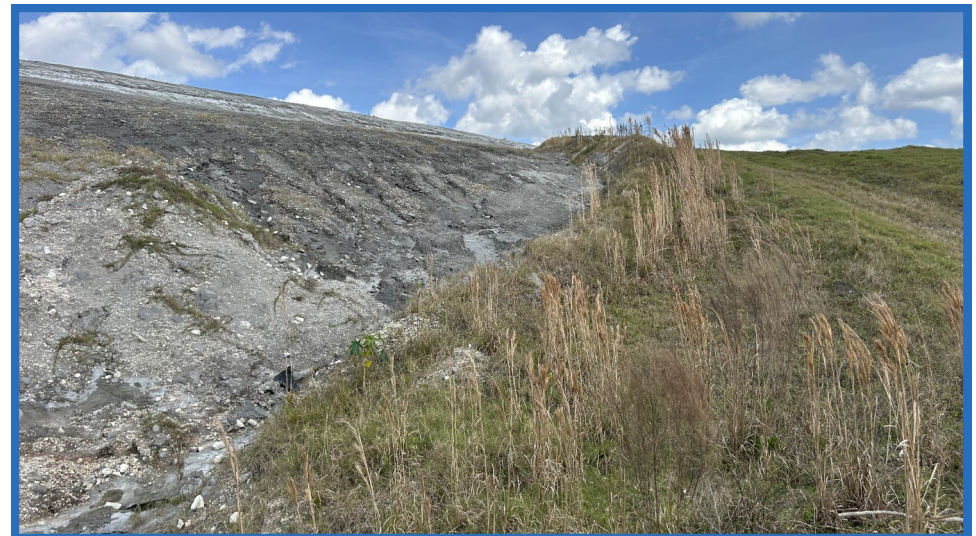
Along the southern boundary of the slope area of Cell 1 that adjoins the closed original CWSA, all waste materials were observed to be inside the lined area. However, some waste materials or runoff sediments may be above the liner anchor trench on the inside slope of the containment dike along the west side of Cell 1 during our landfill inspection on March 8, 2024, but the issue was confirmed to have been properly rectified before our follow-up site visit on May 22, 2024.

Southern Slope of Waste Mound, in Cell 1 Where It Abuts  
Closed Original CWSA, Looking Northeast

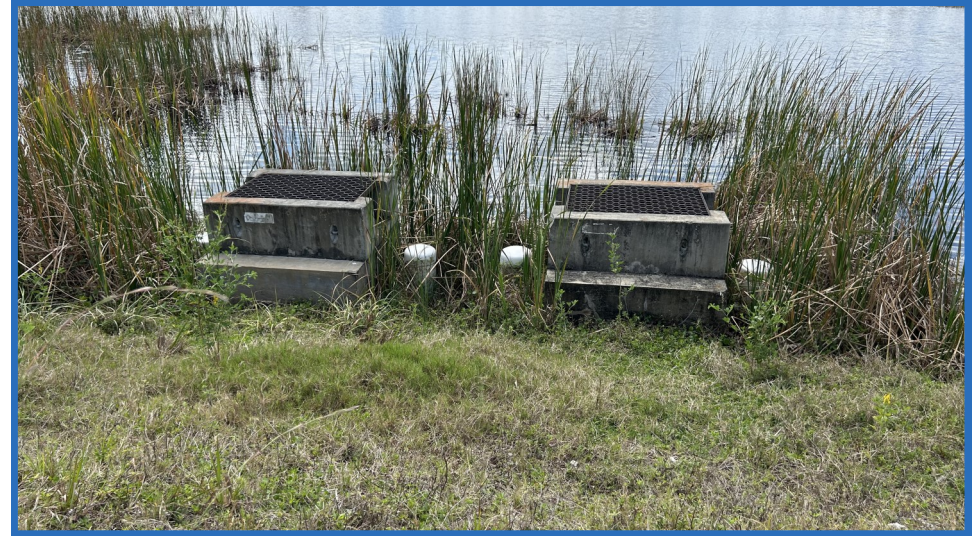
**Discharge Structures for Wet Detention Pond, Looking South-Southwest**

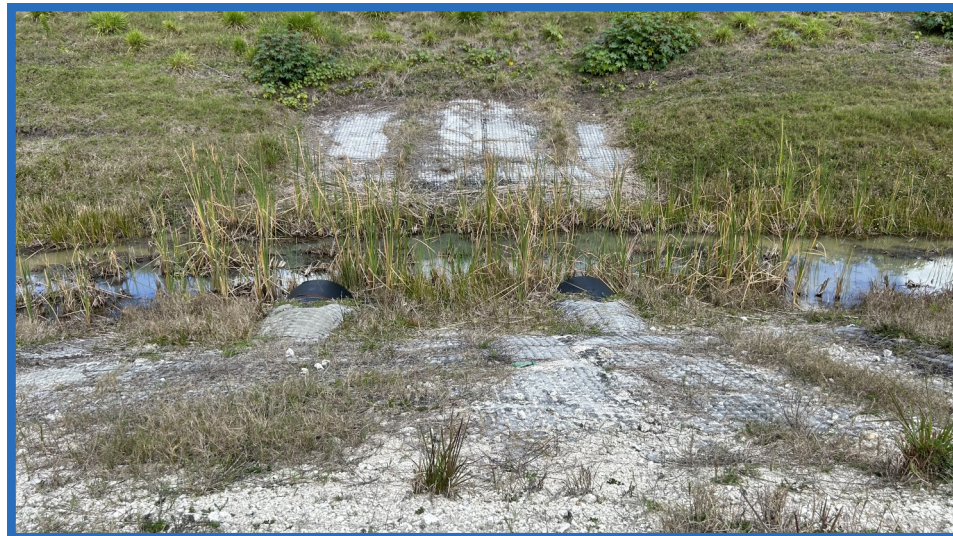
**Fabriform with Discharge Pipes from Wet Detention Pond into Perimeter Stormwater Ditch, Looking North-Northwest from Perimeter Dike/Road**

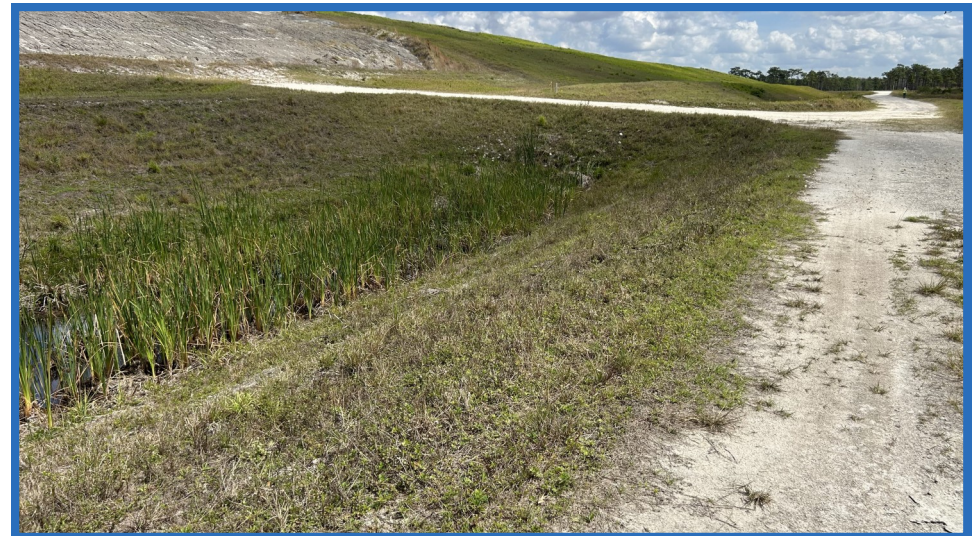
**Perimeter Ditch and Culvert Under Access Ramp Crossing Ditch, Looking Northeast Toward Southern Slope of Waste Mound in Cell 1**

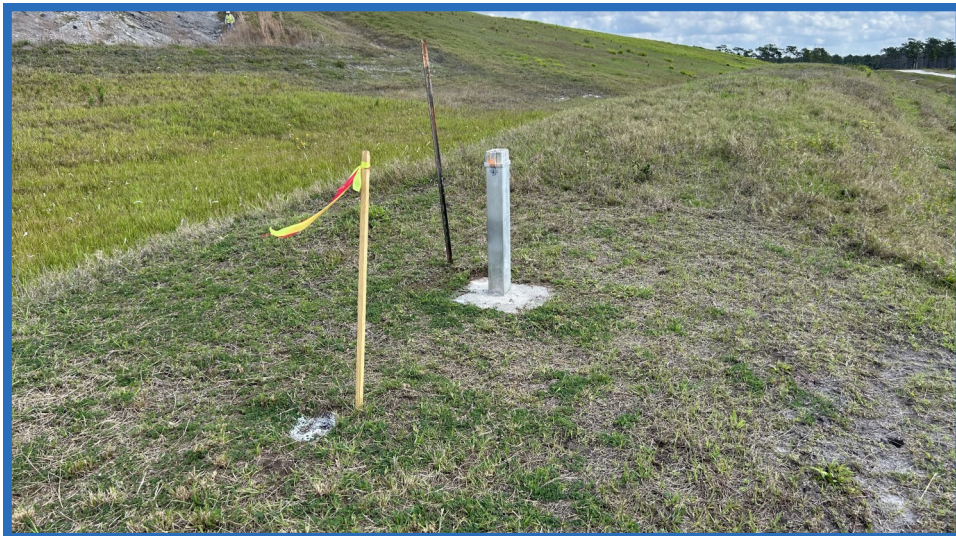
During our site inspection, TT-AAI observed three groundwater monitoring or water level observation wells near Cell 1. These three wells are designated MW-A, MW-9R, and MW-10. Each of these wells was provided with a concrete pad and a metal protective casing. MW-A is located near the southeastern corner of Cell 1. MW-10 is located south of Cell 1 and near the northwestern corner of the wet detention pond. MW-9R is located west of and near the southwestern corner of Cell 1. All three wells appeared to be in good conditions without any visible damages.

Monitoring Well MW-A on Southern Side of Cell 1

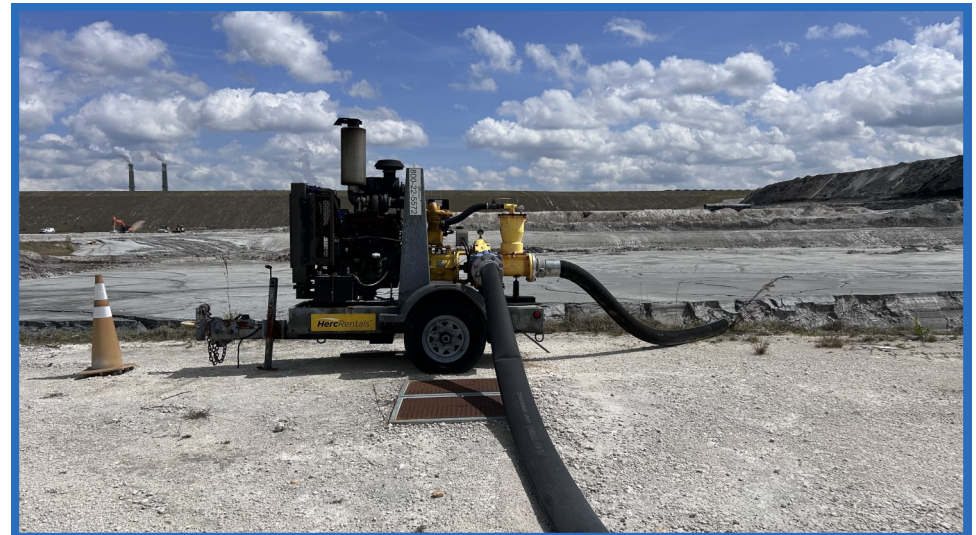
Two trailer-mounted auxiliary diesel pumps were observed on the crest road of the west containment dike near the southwestern corner of Cell 2, with the pump intakes placed in Subcells 1 and 2 of Cell 2. The auxiliary pumps were not operating at the time of our site visit.

Diesel Auxiliary Pump with Intake Deployed in Cell 2, Subcell 1, Looking East

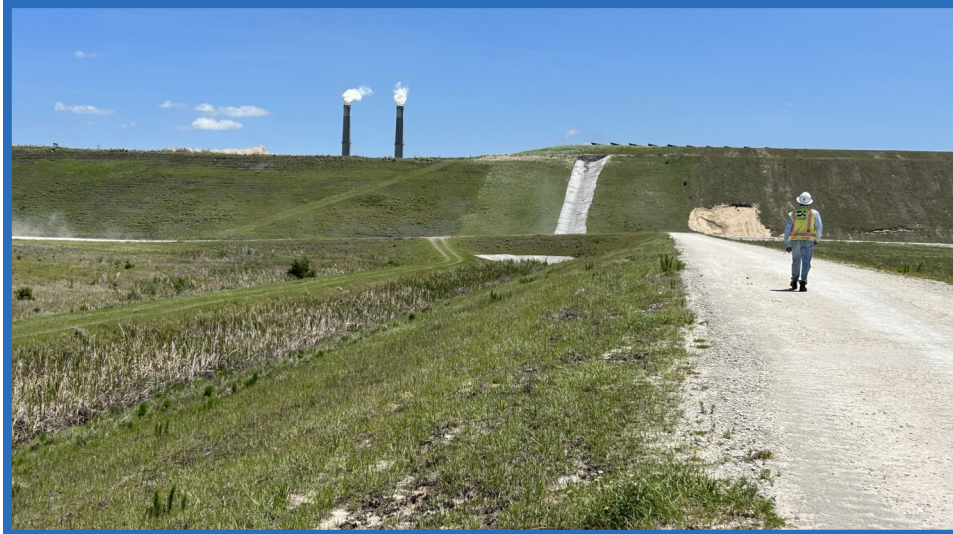
Containment Dike and Perimeter Ditch on North Side of Cell 2, Looking East

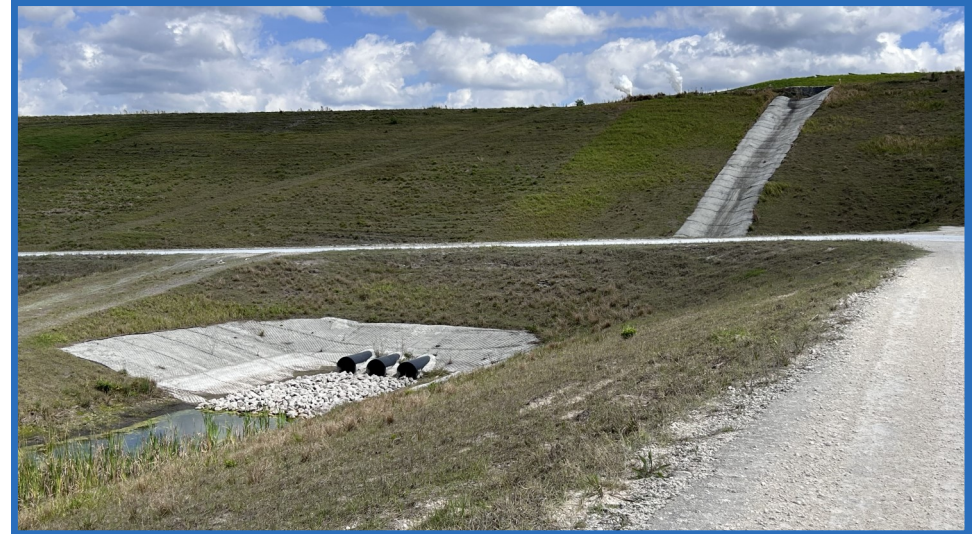
Concrete Flume and HDPE Culverts Draining into Perimeter Ditch on North Side of Cell 2, Looking East-Northeast
