**2025 Annual inspection Under  
Coal Combustion Residuals Rule  
Orlando Utilities Commission  
Stanton Energy Center  
Orange County, Florida**

Subject: 2025 Annual Landfill Inspection under Coal Combustion Residuals (CCR) Rule,  
Stanton Energy Center, Orange County, Florida

**Selected Photographs from 2025 Annual Inspection**

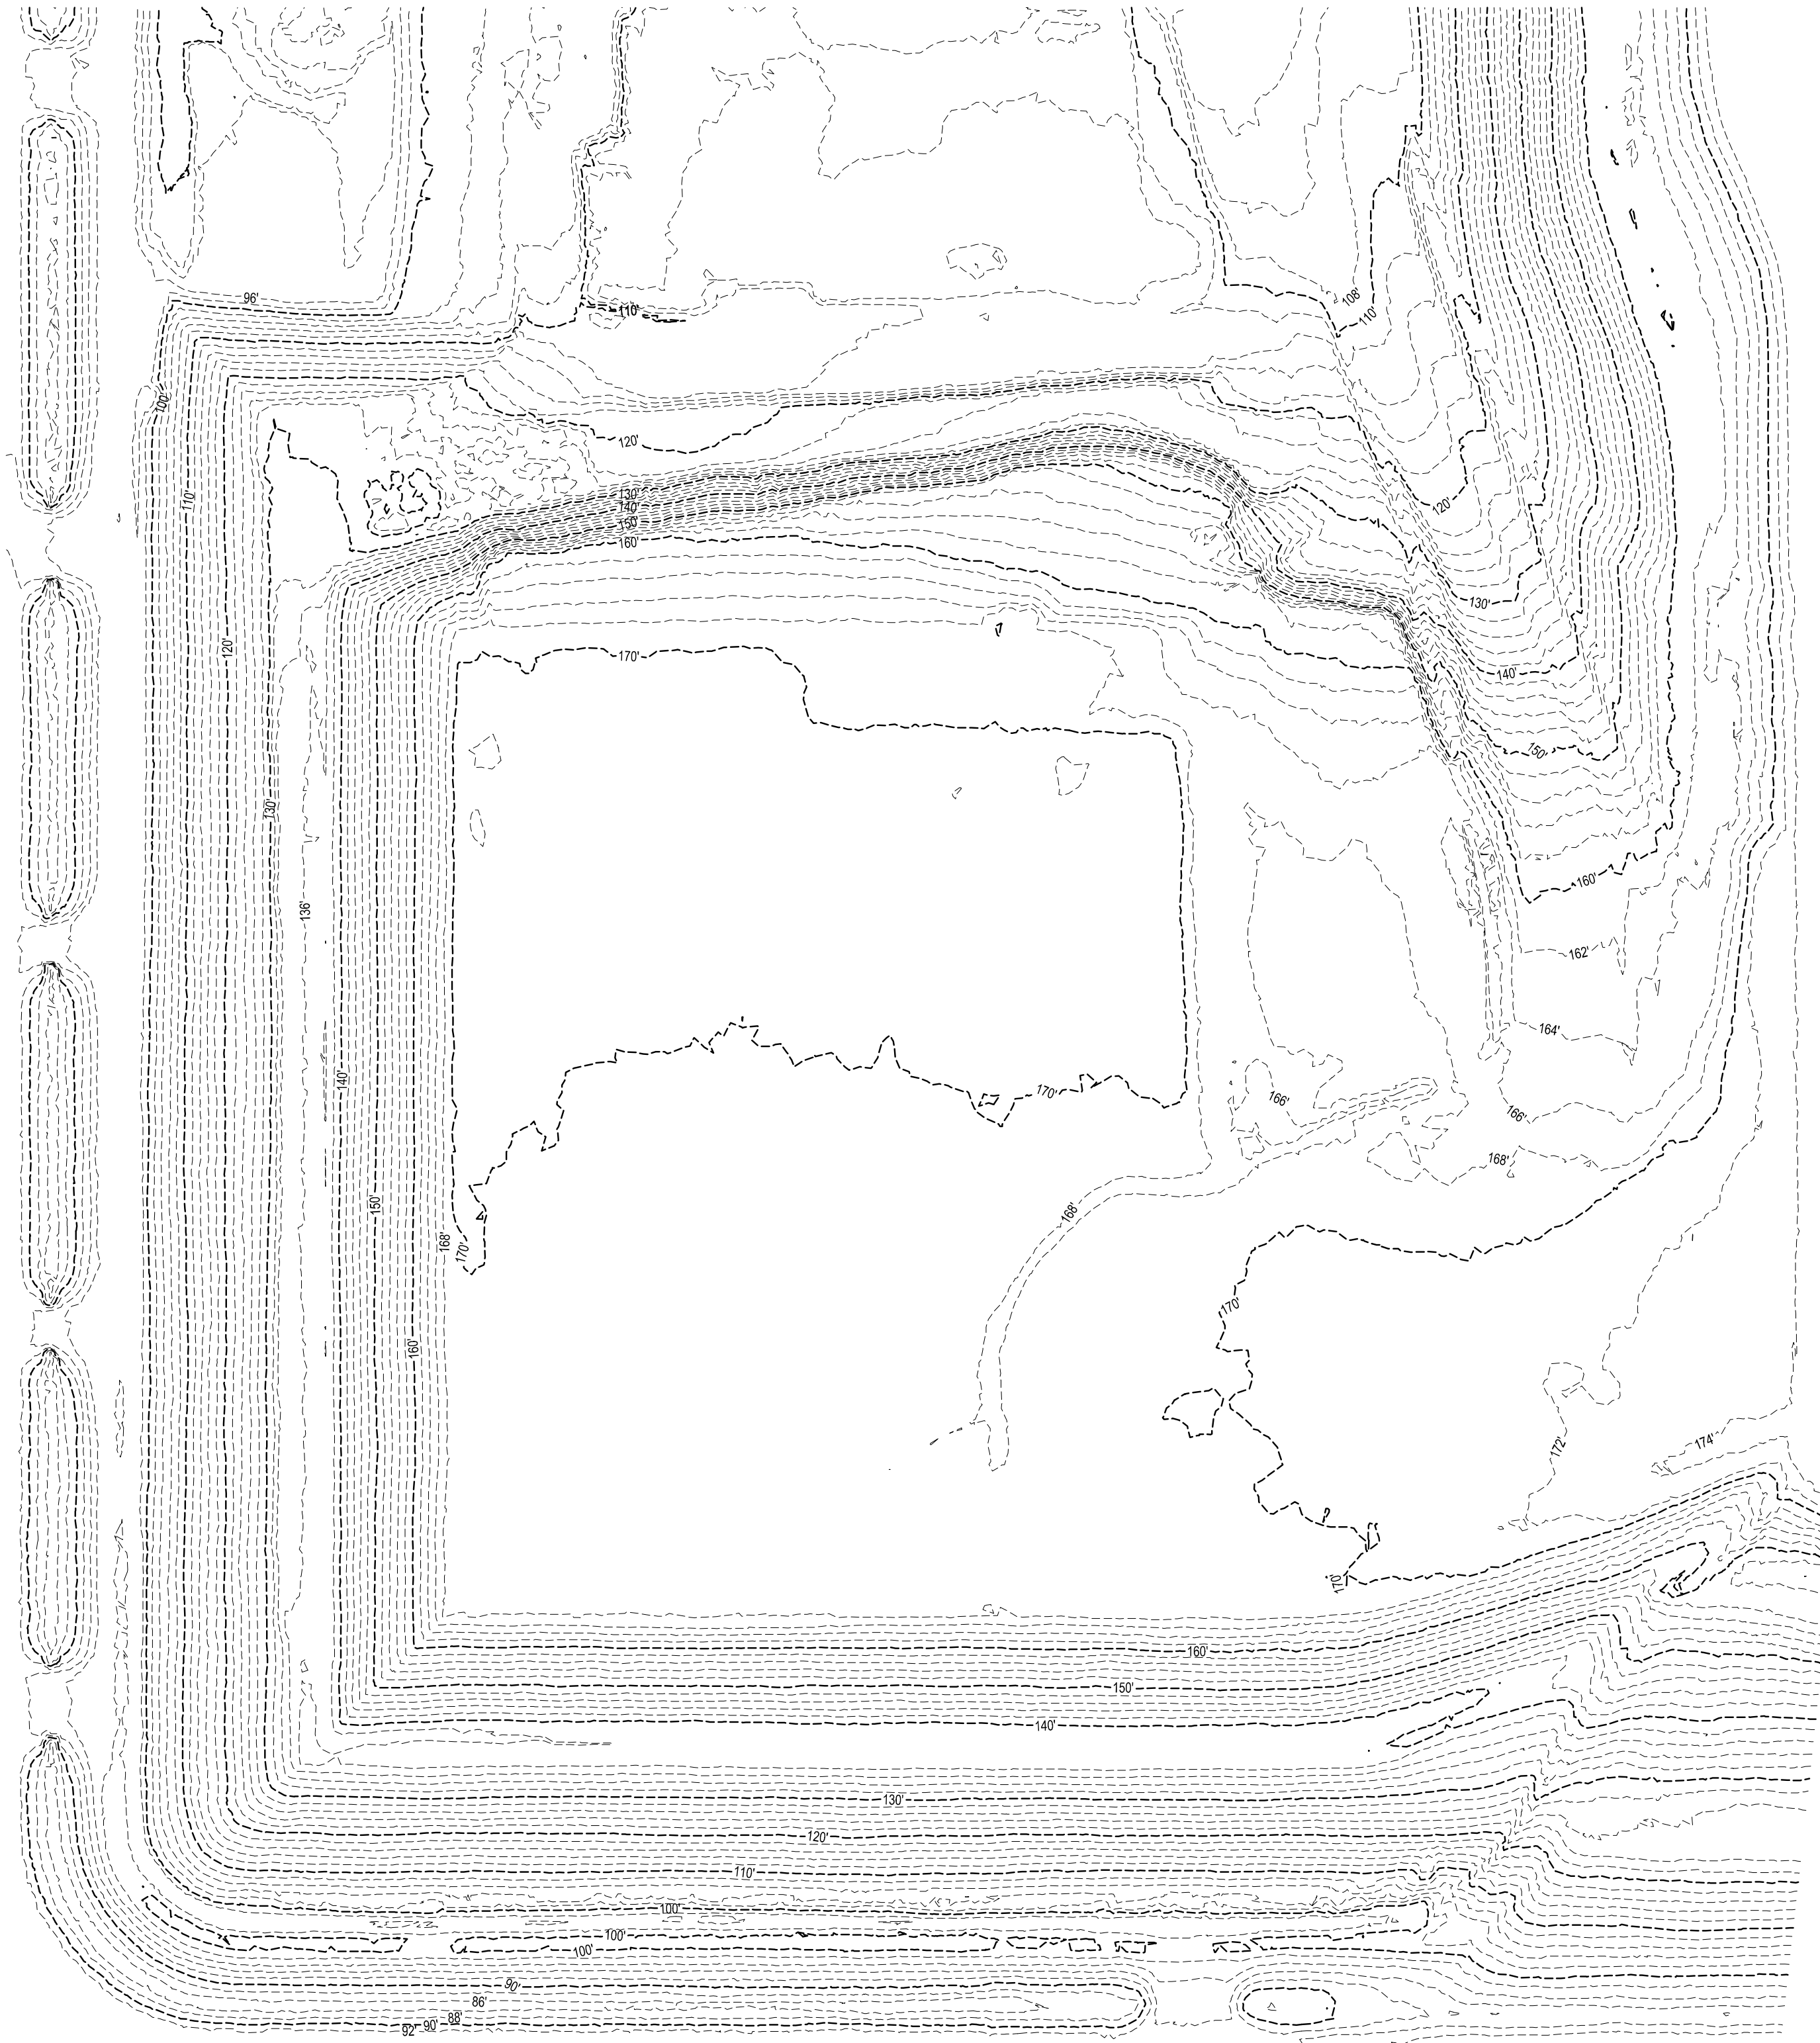
5. All map features contained herein represents actual visible site conditions existing at the time of aerial photography and LiDAR captured simultaneously April 16, 2024.

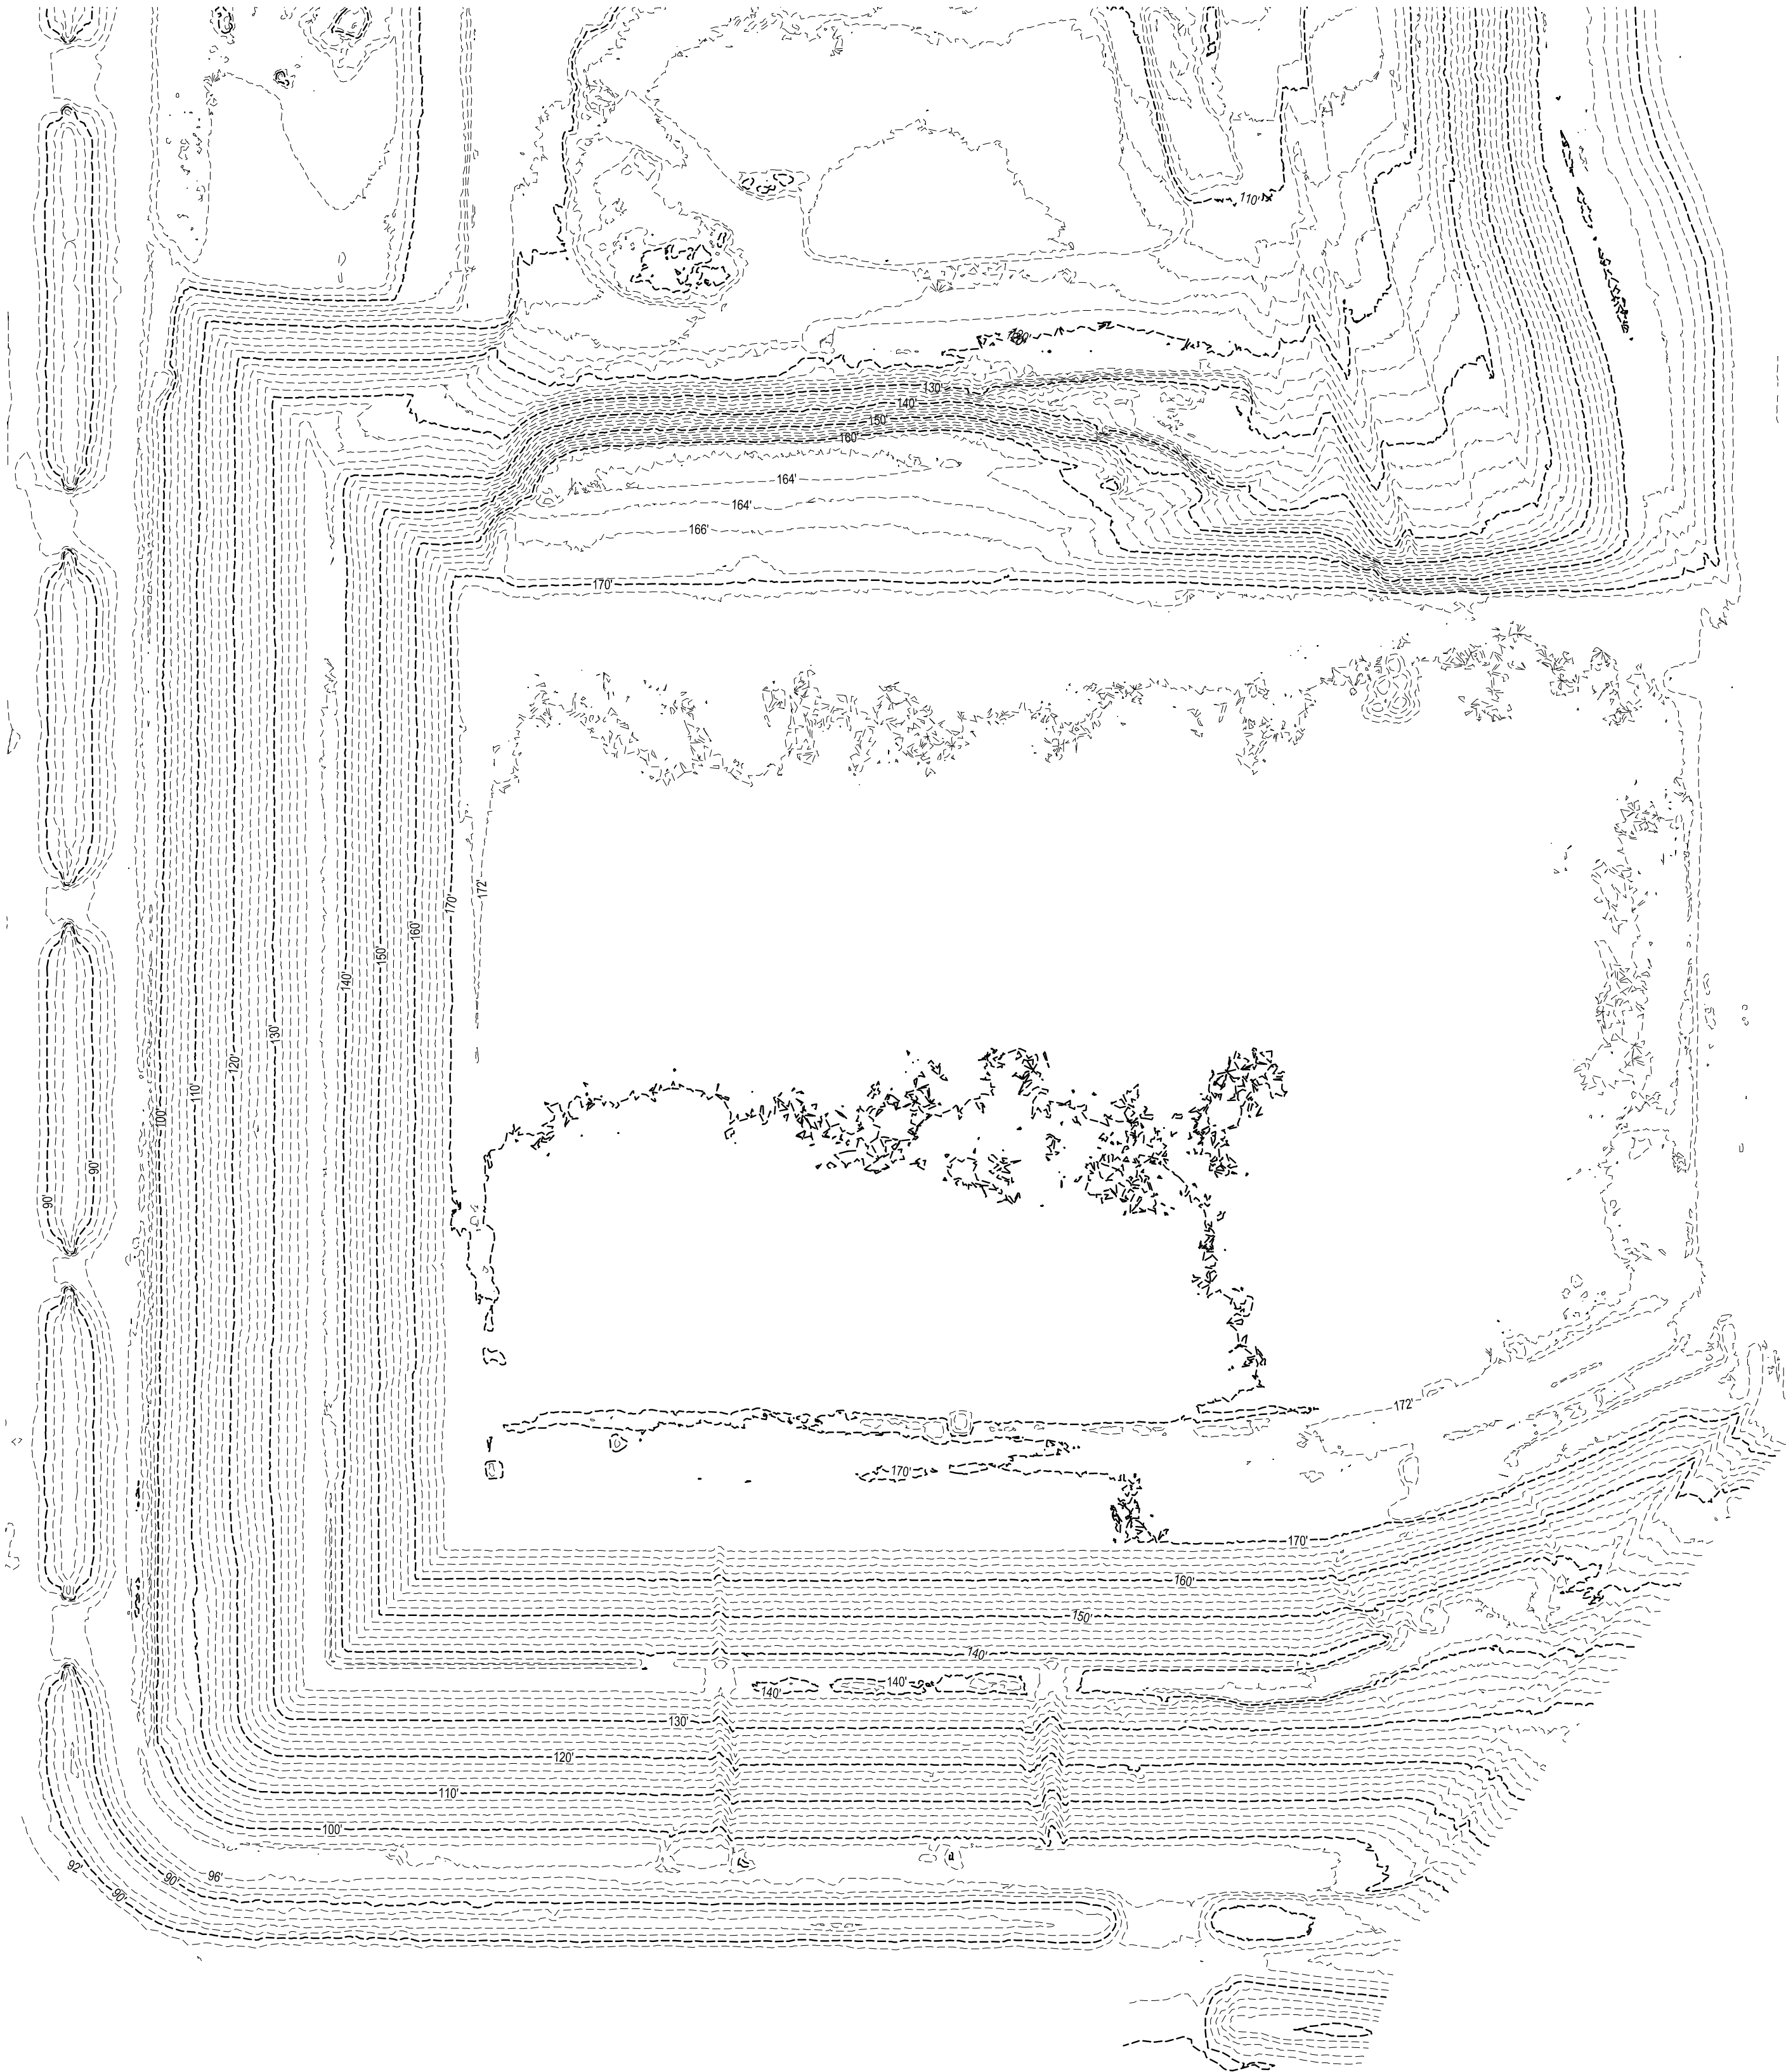
| SURFACE | FILL<br>(CY) | CUT<br>(CY) | NET FILL<br>(CY) |
| AVAILABLE VOLUME REMAINING FROM<br>NOVEMBER 2024 SURVEY TO TOP OF<br>WASTE FINAL DESIGN TEMPLATE | 288693.51 | 11956.14 | CELL FULL |

- All map features contained herein represents actual visible site conditions existing at the time of aerial photography and LiDAR captured simultaneously April 16, 2024.

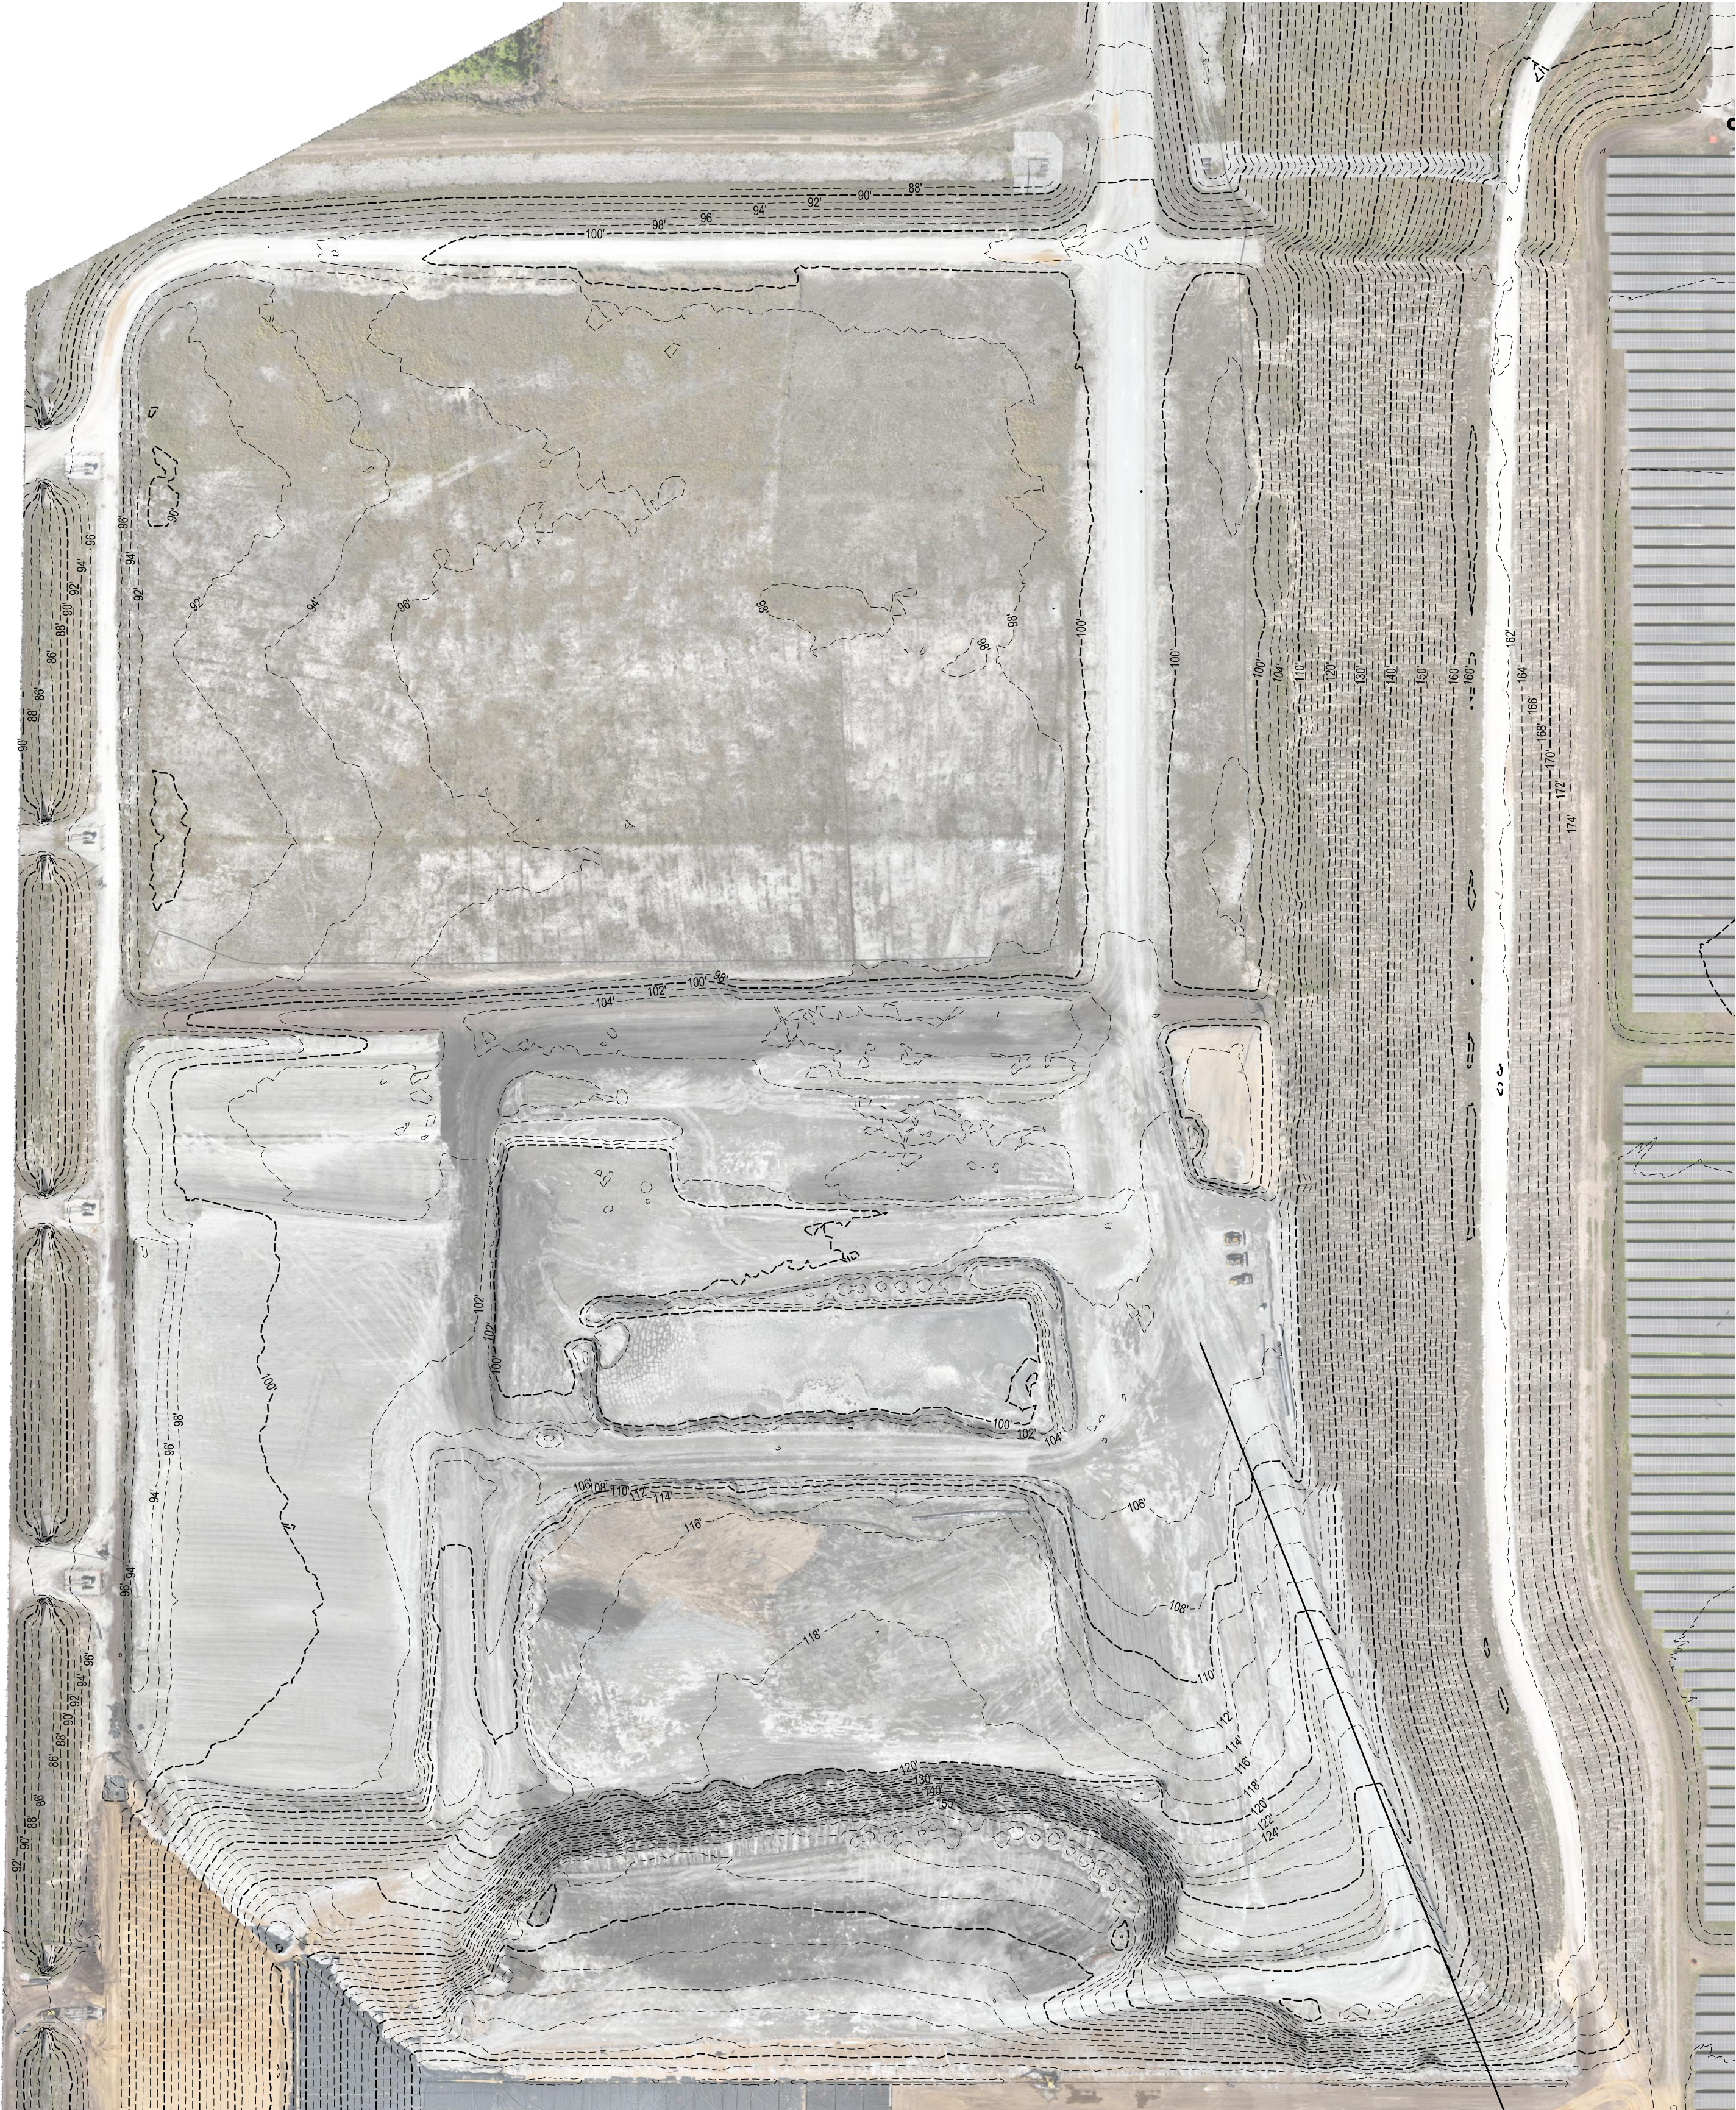
| SURFACE | FILL<br>(CY) | CUT<br>(CY) | NET FILL<br>(CY) |
| VOLUME REMAINING<br>TO FINAL DESIGN | | | N/A |

- All map features contained herein represents actual visible site conditions existing at the time of aerial photography and LIDAR captured simultaneously March 22, 2025.

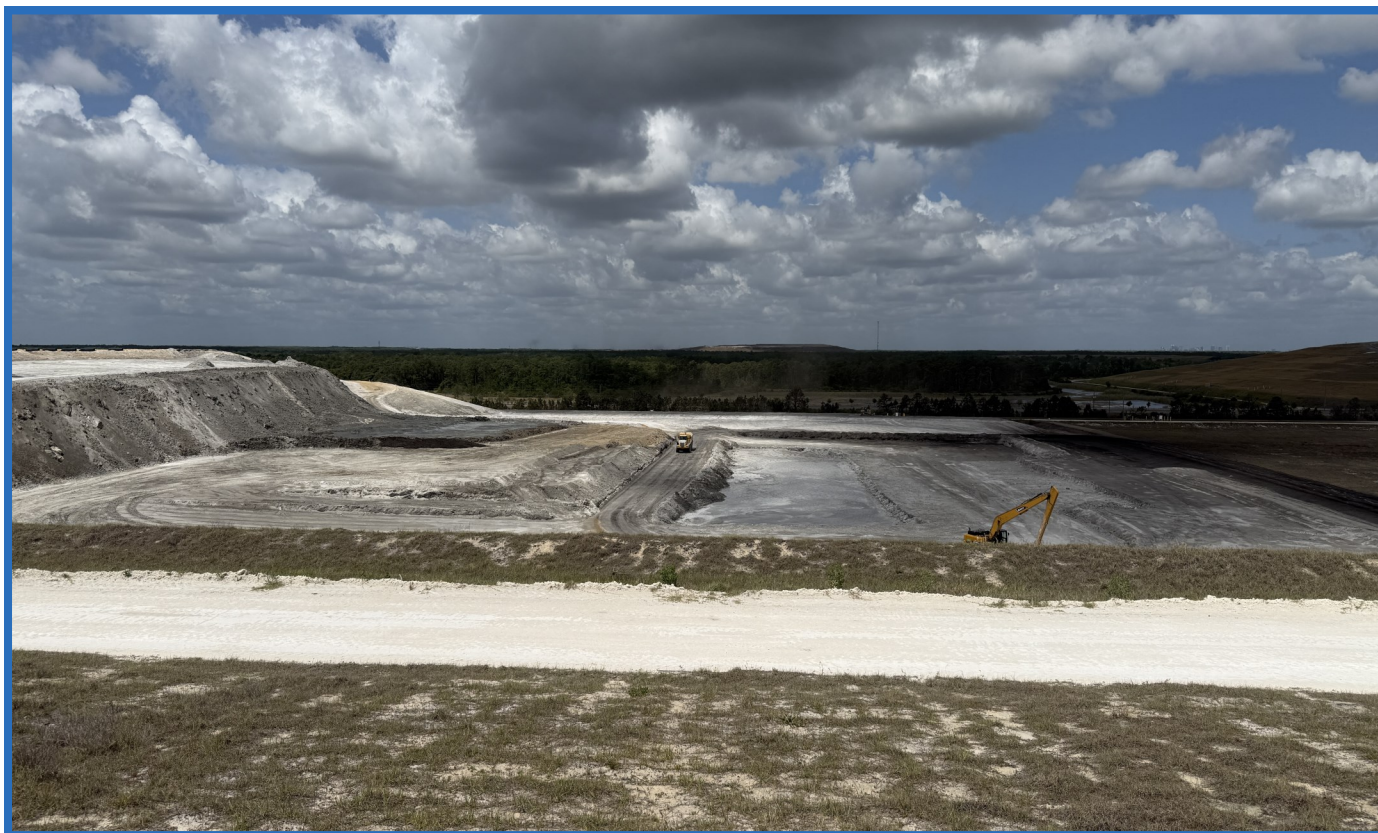
We began the landfills inspection by observing Cells 1 and 2 from the top of the closed vertical expansion, at an elevation of approximately +175 feet (NAVD88). Cell 1 was undergoing closure construction. Waste materials were also observed on the south side of the bottom and slope areas of Cell 2 abutting the CWSA.

**Waste Placed in Cell 2 bottom and slope areas (Looking West from top of the Closed Vertical Expansion of Original CWSA)**

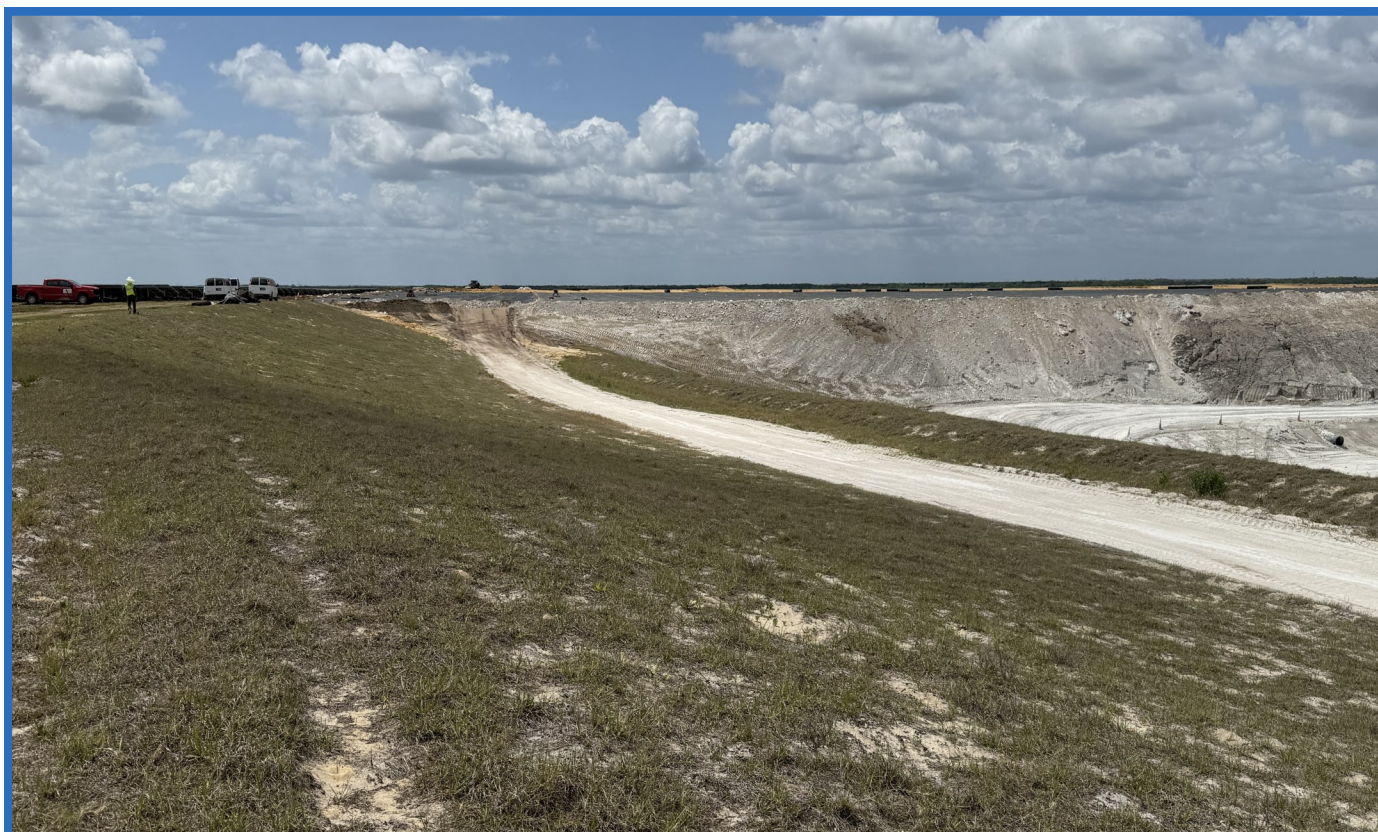
**Junction of Waste Mound in Cell 1 with Cell 2, abutting the western slope of Original CWSA (Looking South from top of the Closed Vertical Expansion of Original CWSA)**

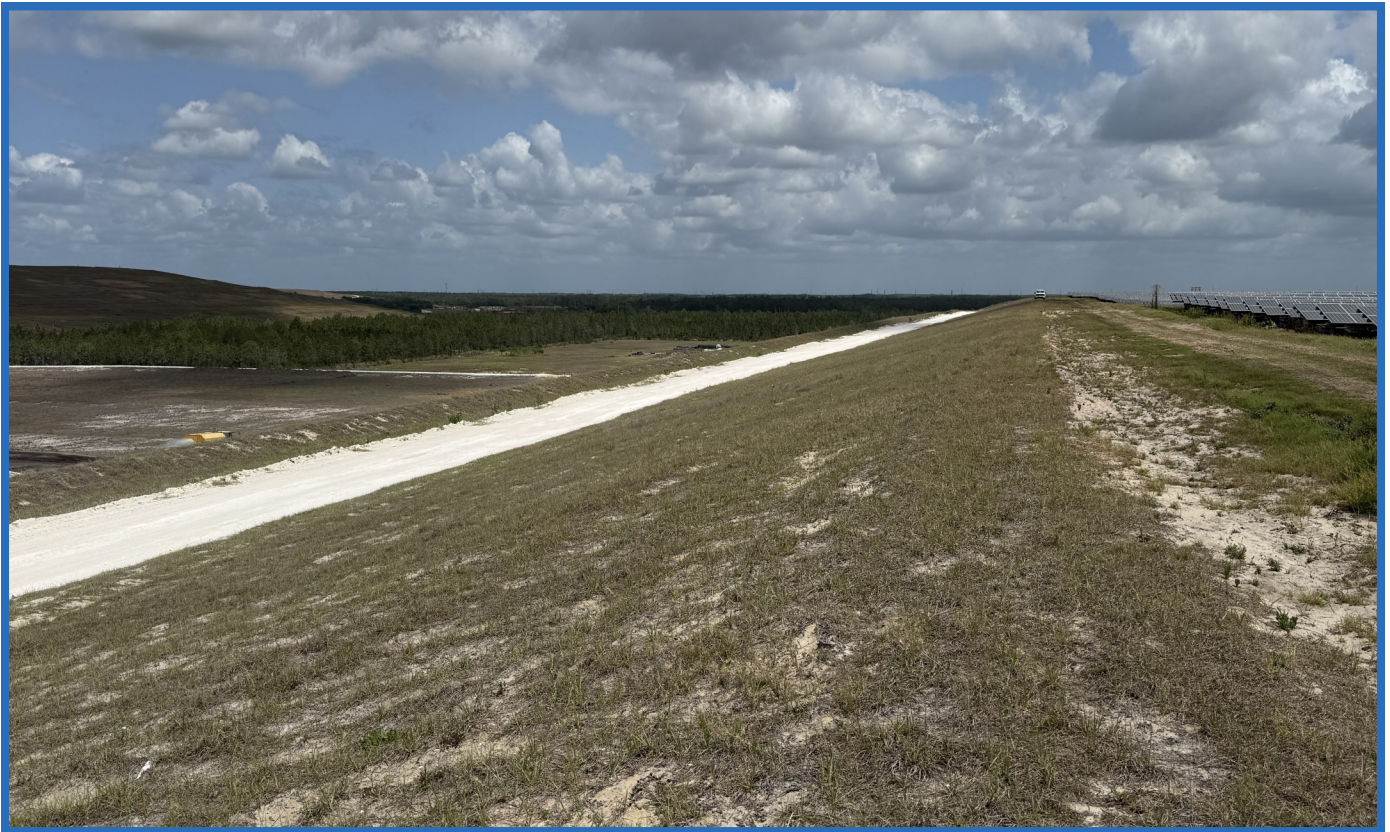
**Slope Areas of Cell 2 and two Southern Sub-cells of Cell 2 (Looking North from top of the Closed Vertical Expansion of Original CWSA)**

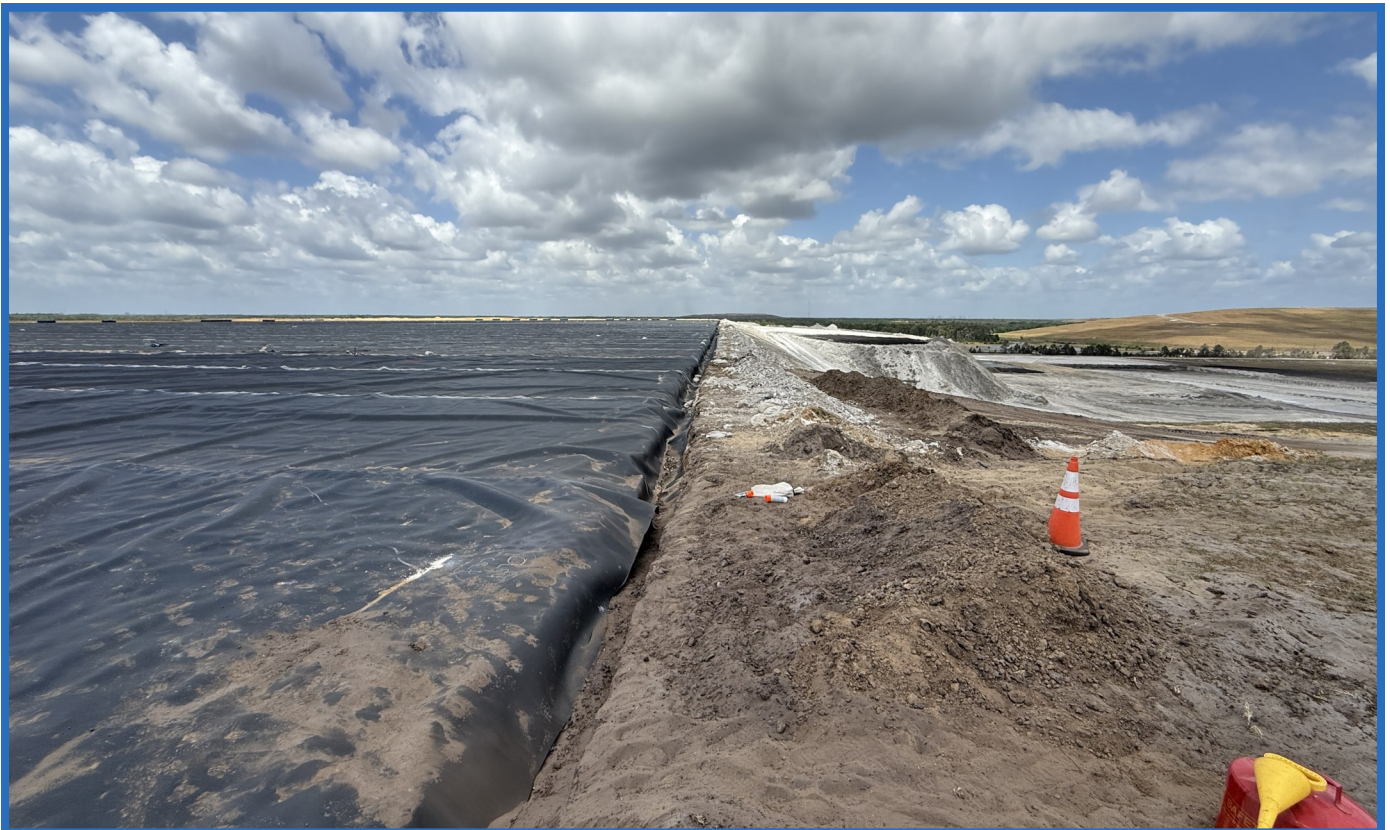
**North Anchor Trench of Closure Liner atop Cell 1, Waste in Cell 2 Abutting Northern Slope of Cell 1 (Looking North from top of the Closed Vertical Expansion of Original CWSA)**

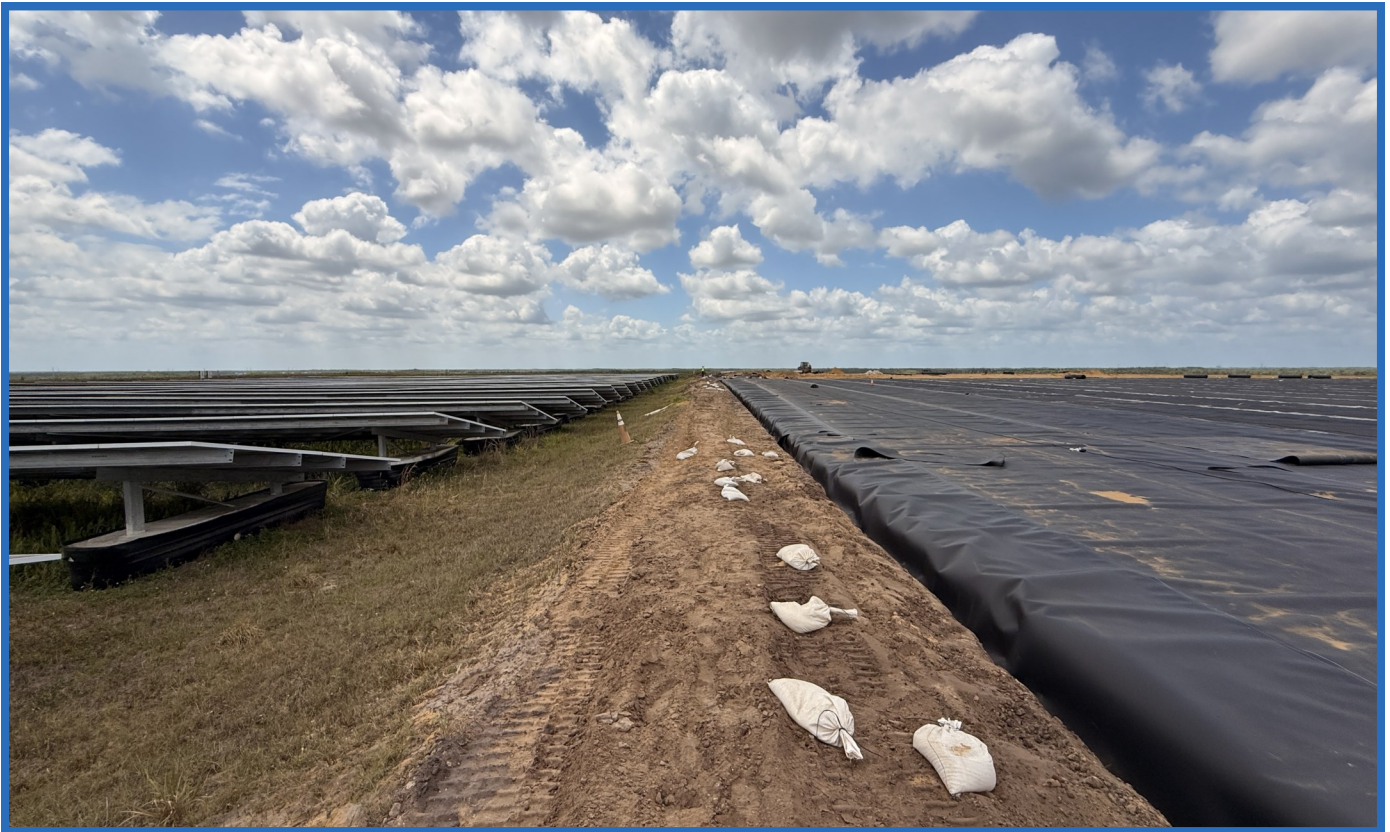
**East Anchor Trench of Closure Liner atop Cell 1 (Looking South from top of the Closed Vertical Expansion of Original CWSA)**

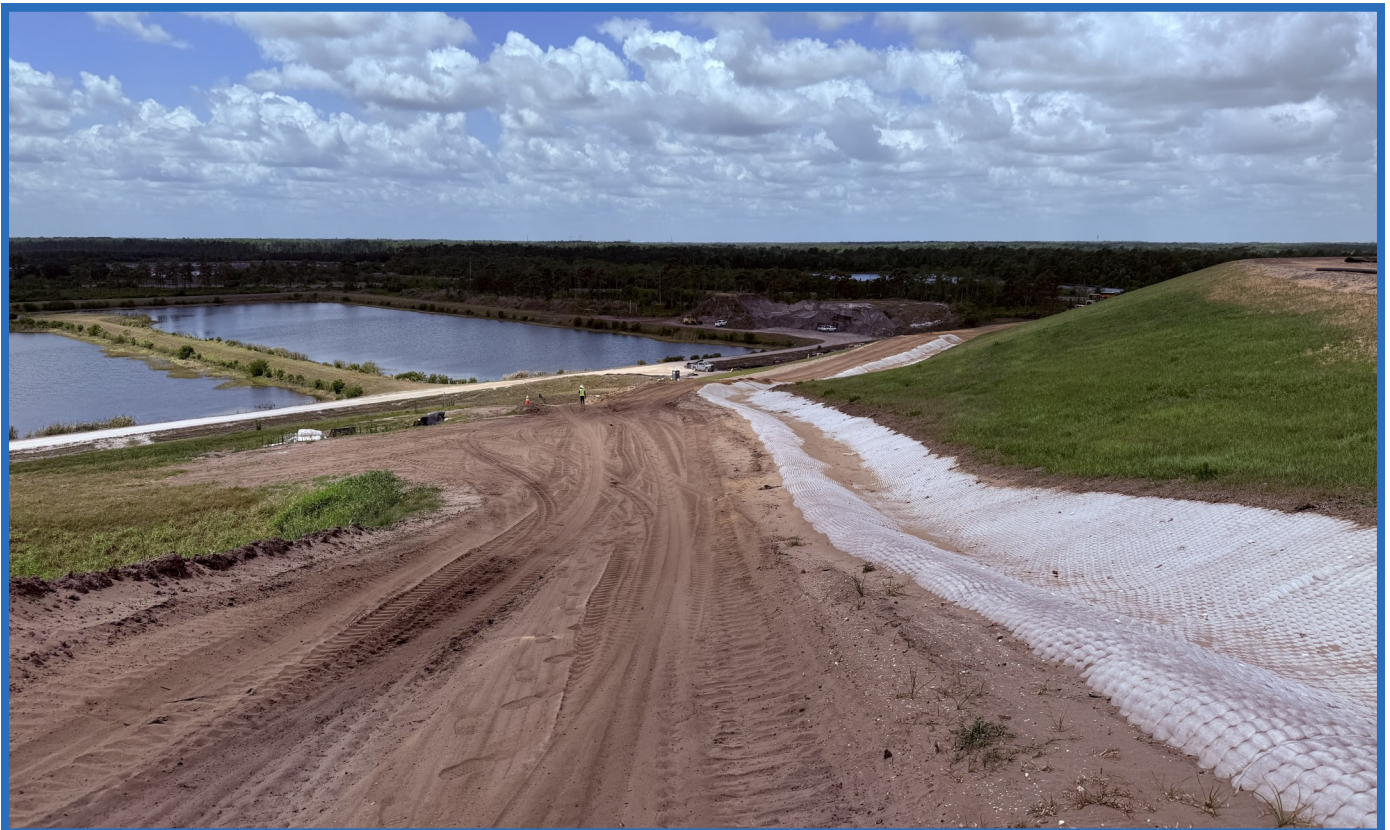
**Ramp from Containment Dike of Cell 1 to top of Closed Vertical Expansion of Original CWSA (Looking Southwest from top of the Closed Vertical Expansion of Original CWSA)**

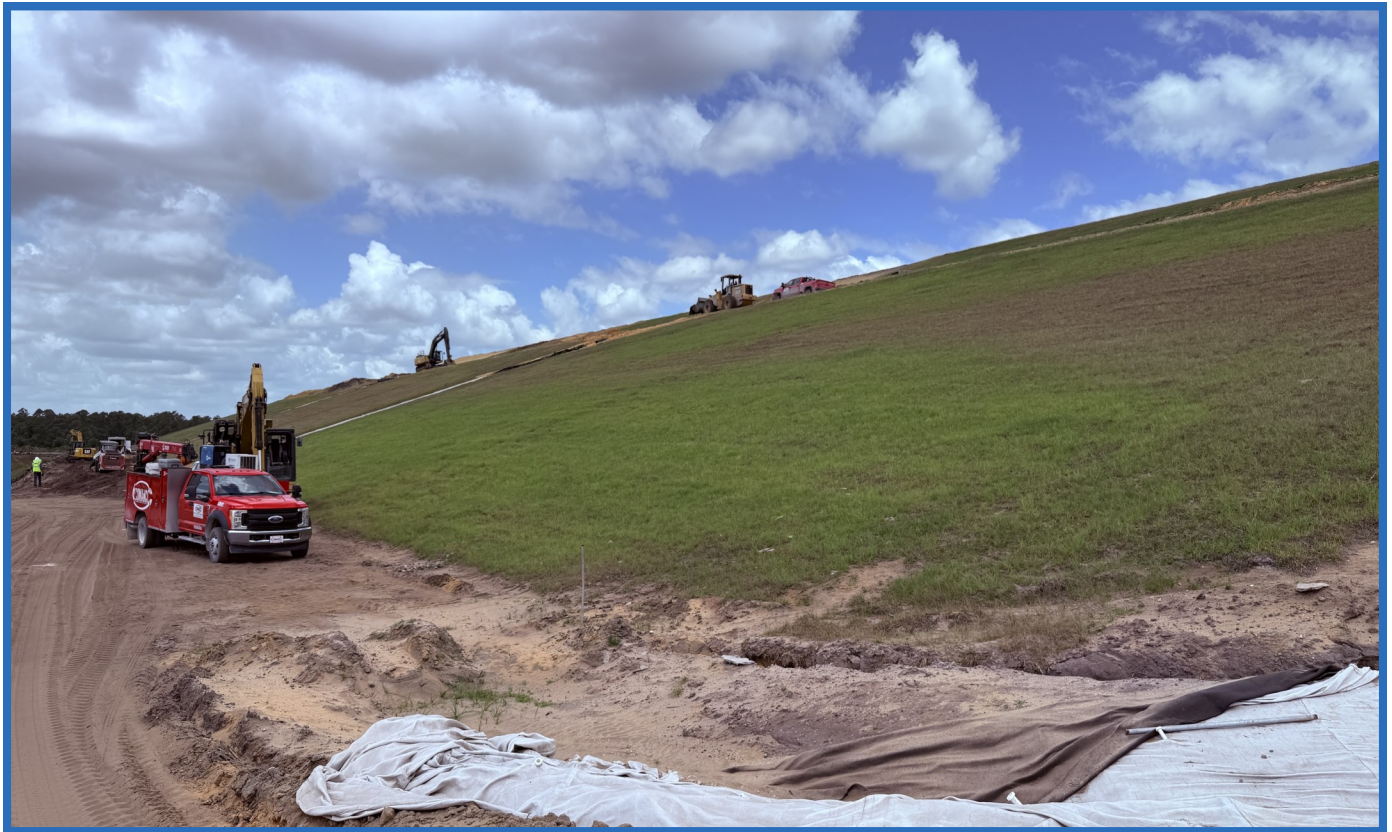
The outside slope of the containment dike, and the inside and outside slopes of the perimeter dike, were generally in a good condition except for some localized spots with sparse grass cover. Based on our visual observations, flow should occur freely through the stormwater drainage ditch and box culverts that were constructed between the containment and perimeter dikes along the west side of Cells 1 and 2 and the south side of Cell 1. The two inlets on the south side of Cell 1, which are connected to pipes draining into the wet detention pond near its northwestern corner, were also in a good condition.

**Sod on Lower Slopes on Cell 1 Currently Undergoing Closure (Looking Northwest from Containment Dike on South of Cell 1)**

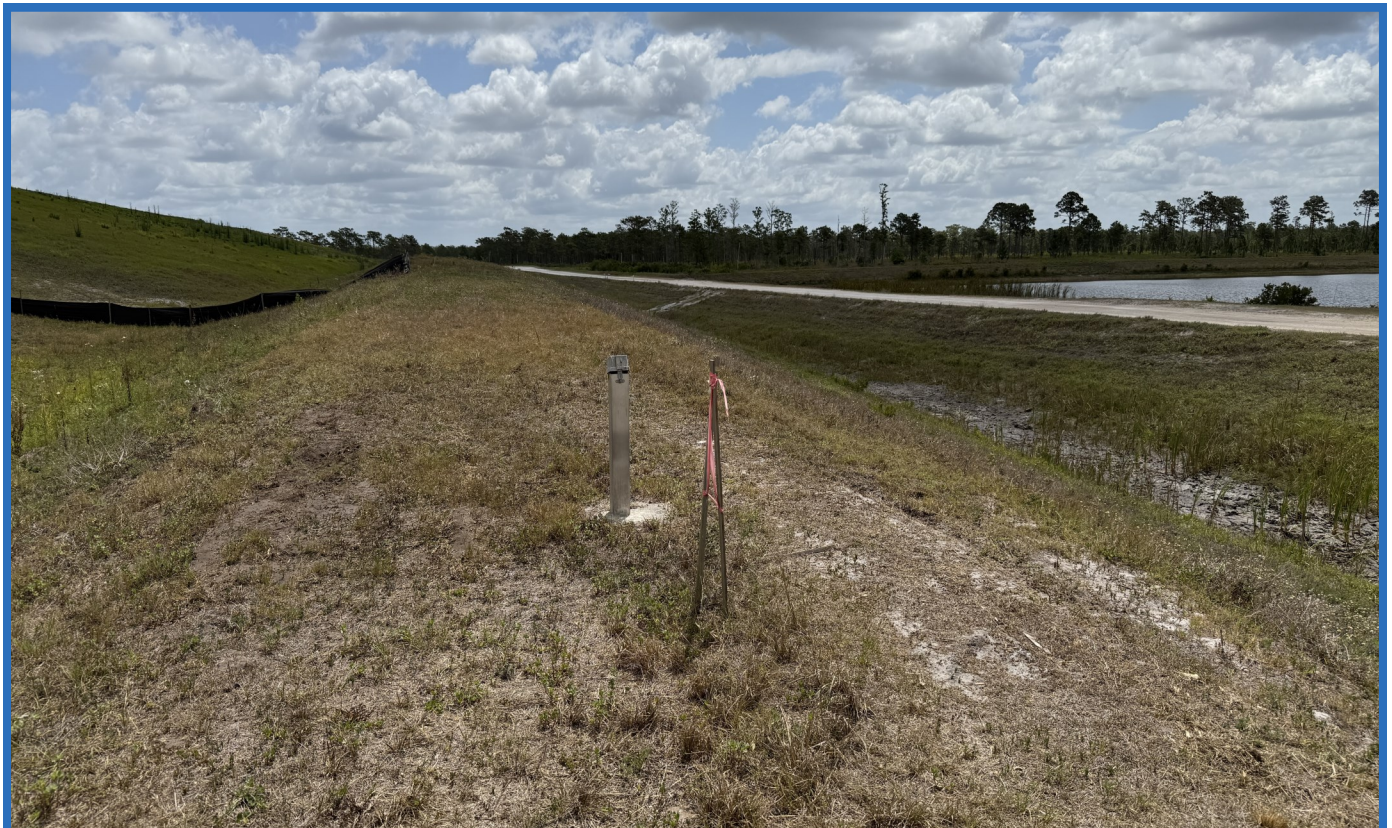
During our site inspection, TT-AAI observed three groundwater monitoring or water level observation wells near Cell 1. Each of these wells was provided with a concrete pad and a metal protective casing. MW-A is located near the southeastern corner of Cell 1. MW-10 is located south of Cell 1 and near the northwestern corner of the wet detention pond. The well located west of and near the southwestern corner of Cell 1 had a tag identifying the well as MW-9, but the labels on the inside of the aluminum cap and on the well identified this well as MW-8. All three wells appeared to be in good conditions without any visible damages. Since the wells are located inside of a secured facility, none of the wells were locked.

**Monitoring Well MW-A on South Side of Cell 1**

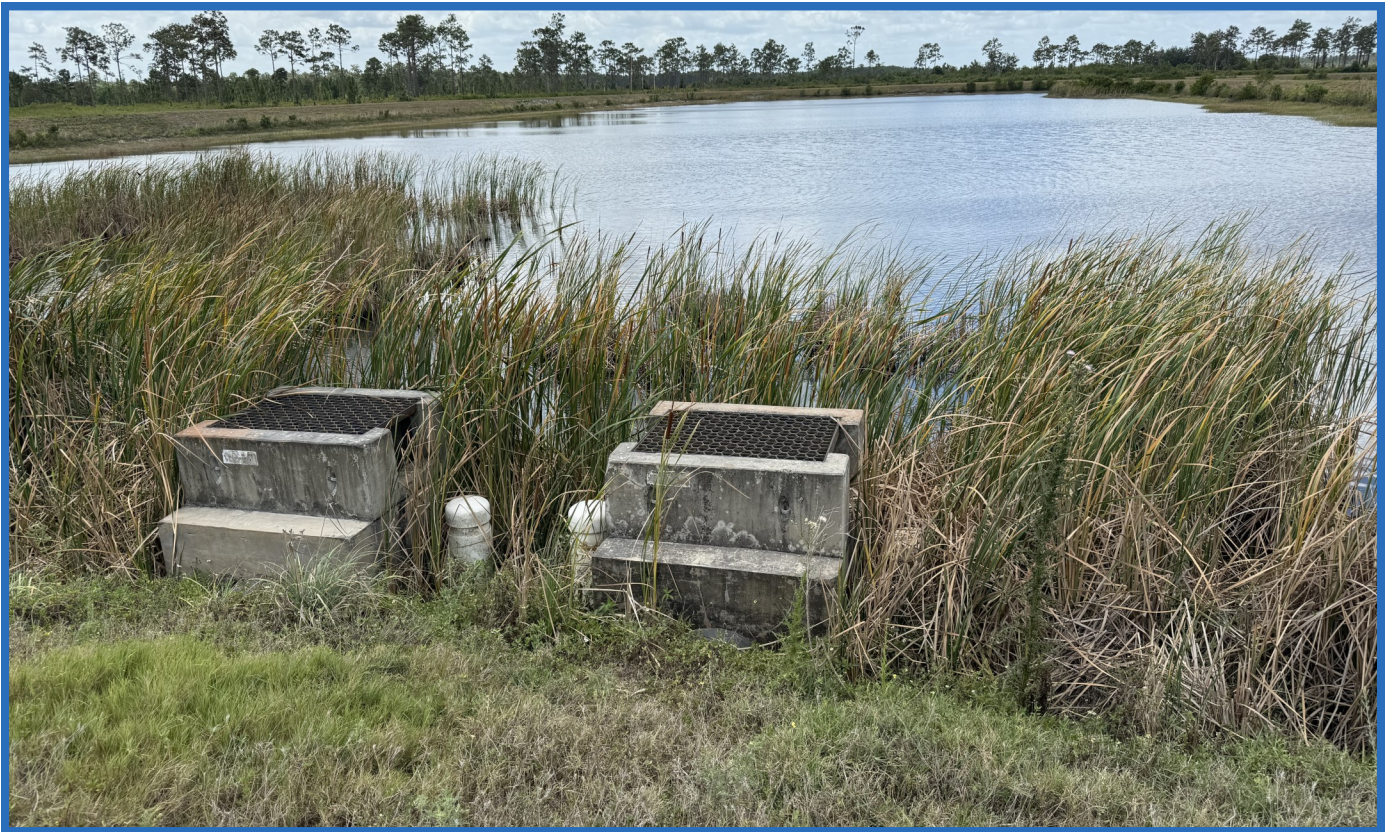
**Discharge Structures for Wet Detention Pond (Looking South-Southeast)**
