**2025 Annual inspection Under  
Coal Combustion Residuals Rule  
Orlando Utilities Commission  
Stanton Energy Center  
Orange County, Florida**

Subject: 2025 Annual Landfill Inspection under Coal Combustion Residuals (CCR) Rule,  
Stanton Energy Center, Orange County, Florida

**Selected Photographs from 2025 Annual Inspection**

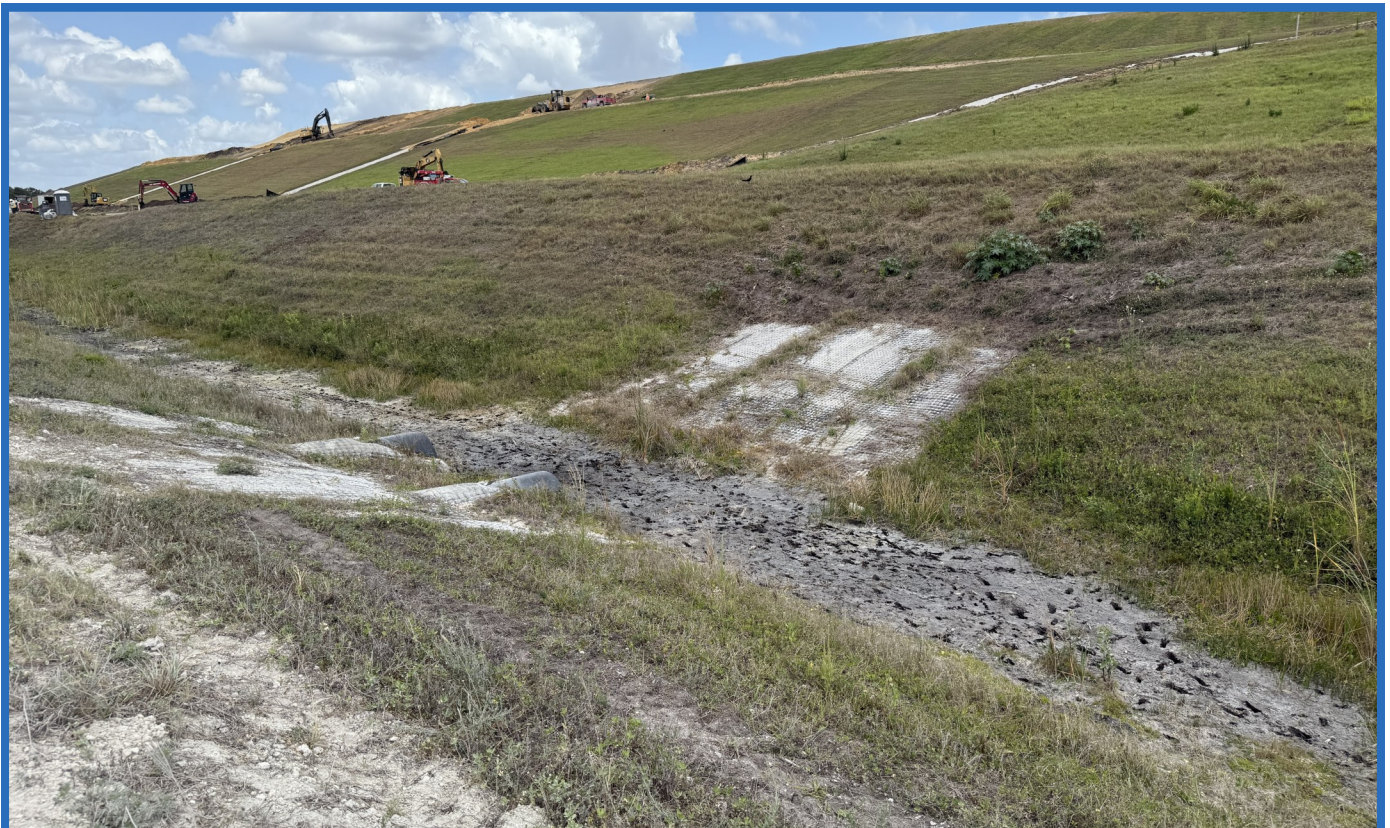
**Fabriform with Discharge Pipes from Wet Detention Pond into Perimeter Storm-water Ditch (Looking Northwest from Perimeter Dike)**

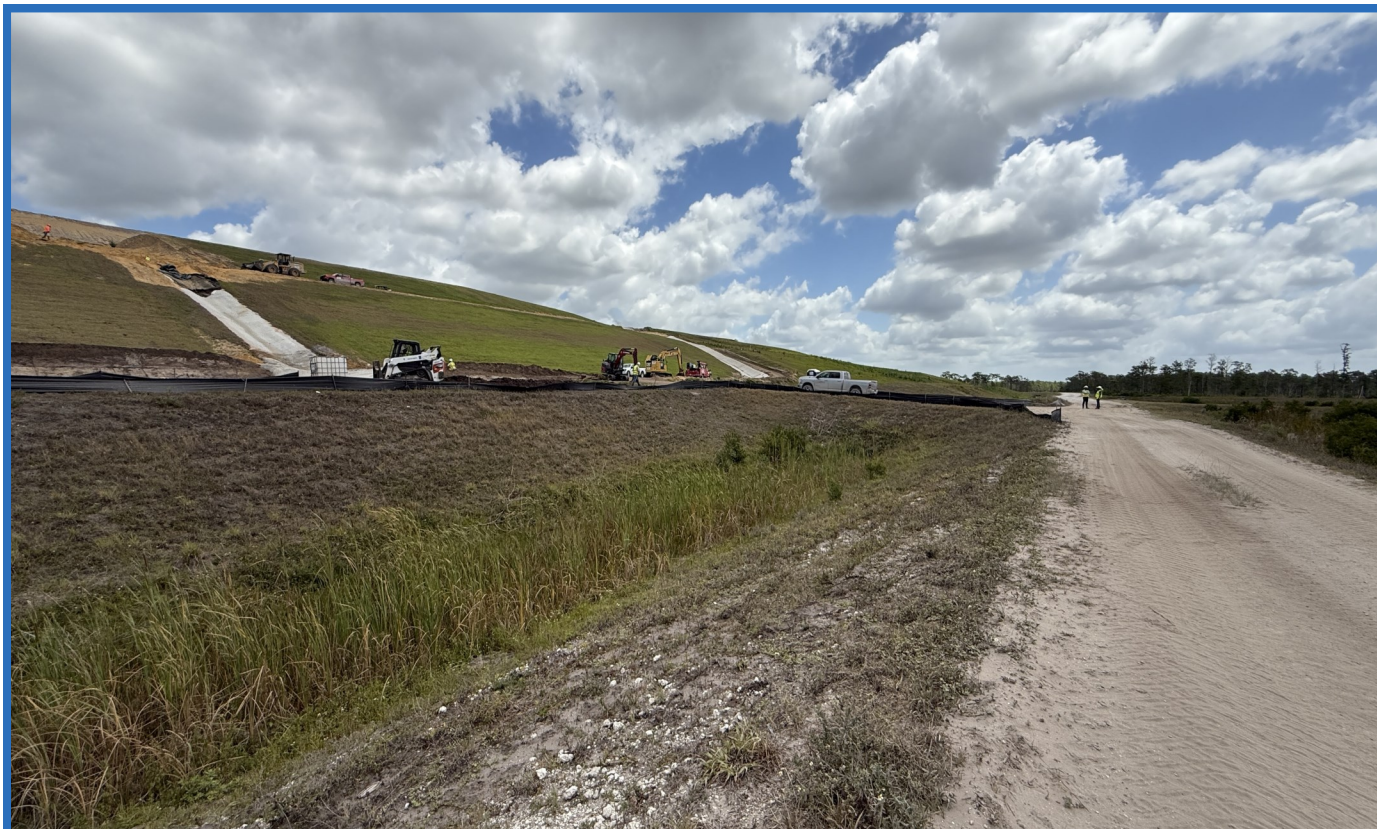
**Perimeter Ditch South of Cell 1 (Looking Northeast towards South Slope of Cell 1 Undergoing Closure)**

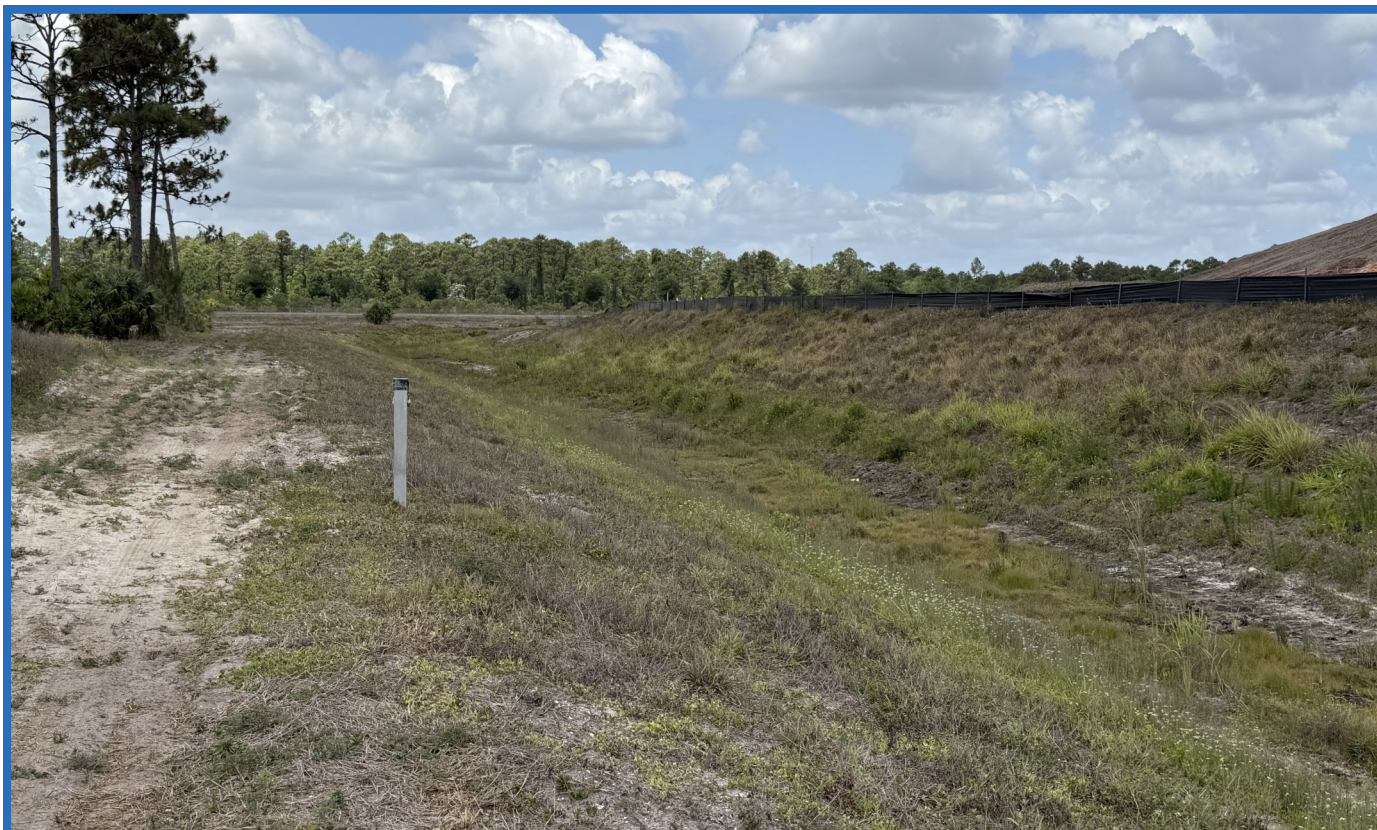
During our site inspection, TT-AAI observed three groundwater monitoring or water level observation wells near Cell 1. Each of these wells was provided with a concrete pad and a metal protective casing. MW-A is located near the southeastern corner of Cell 1. MW-10 is located south of Cell 1 and near the northwestern corner of the wet detention pond. The well located west of and near the southwestern corner of Cell 1 had a tag identifying the well as MW-9, but the labels on the inside of the aluminum cap and on the well identified this well as MW-8. All three wells appeared to be in good conditions without any visible damages. Since the wells are located inside of a secured facility, none of the wells were locked.

**Monitoring Well MW-10 on South Side of Cell 1 (Looking East)**

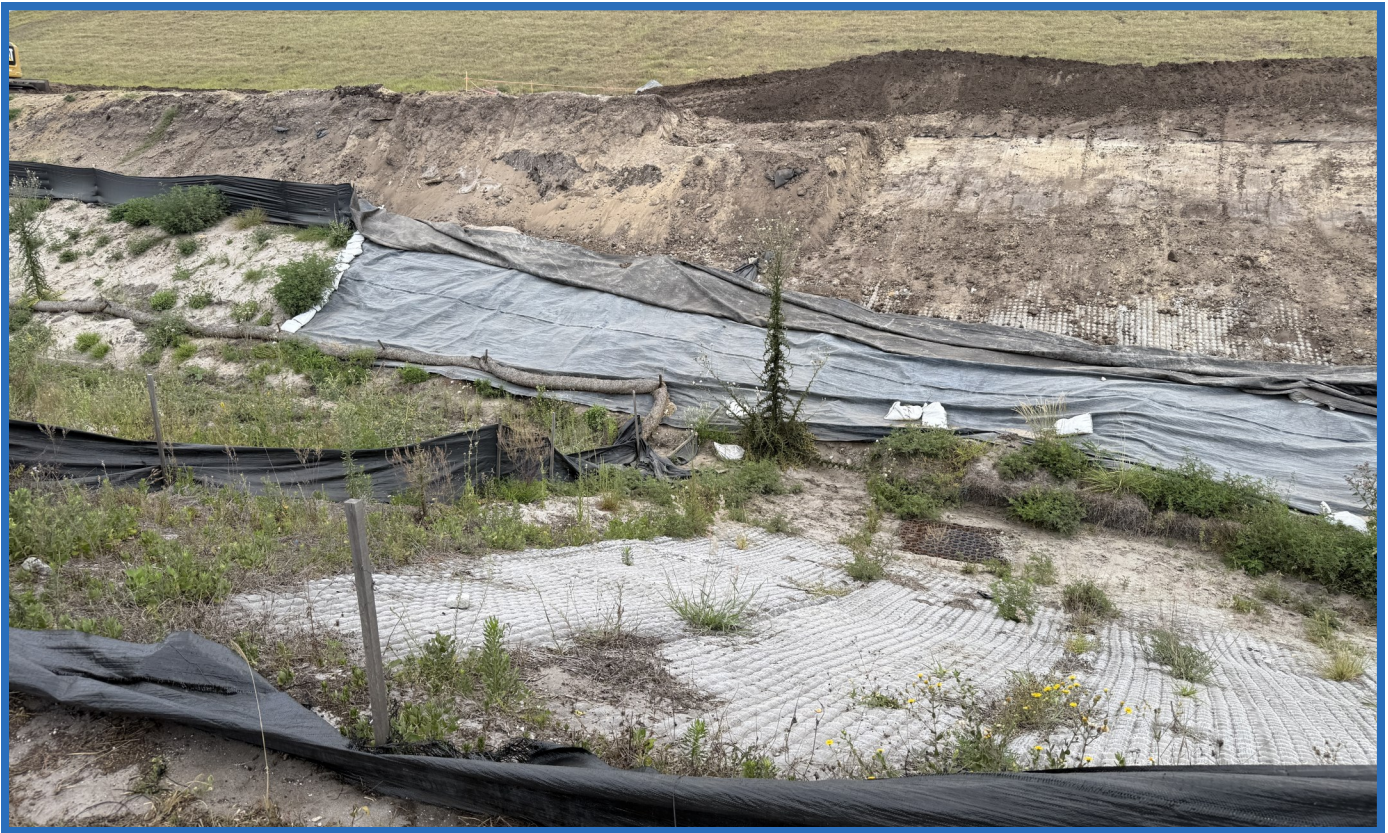
**Fabriform with Inlets to Wet Detention Pond in Stormwater Ditch South of Cell 1  
(Looking North from Cell 1 Perimeter Dike)**

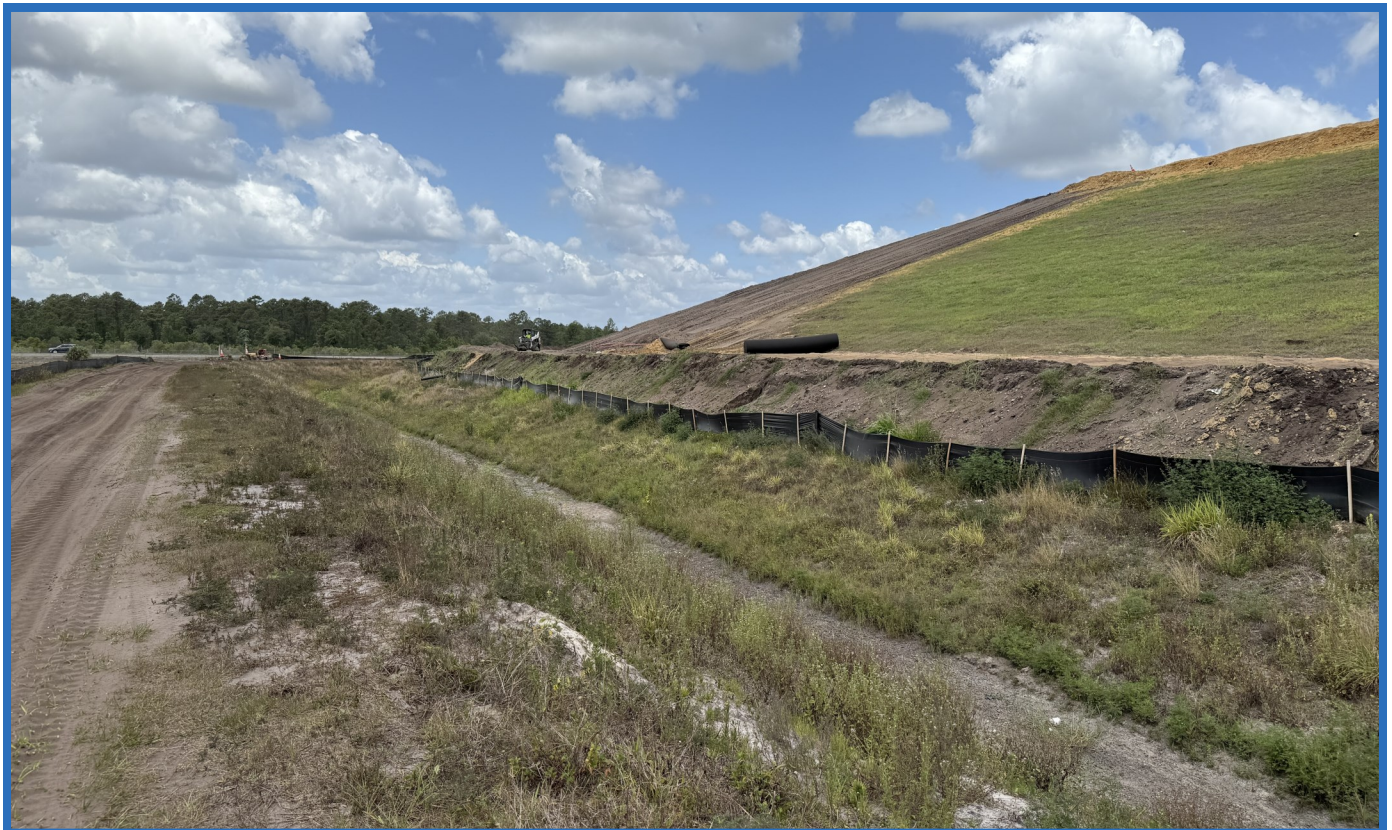
**Stormwater Ditch Between Perimeter Dike and Containment Dike of Cell 1 Under-  
going Closure (Looking East from Perimeter Dike)**

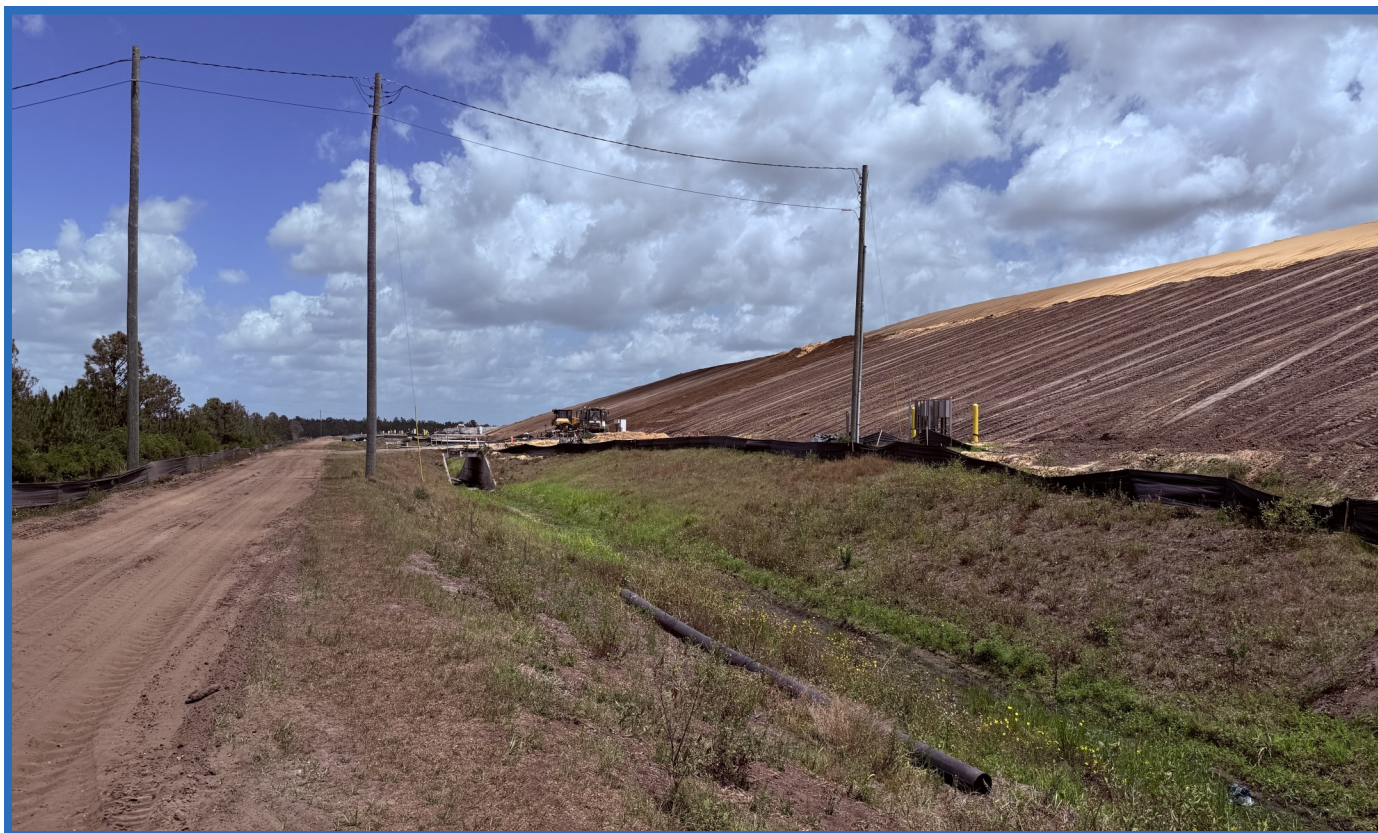
**Stormwater Ditch Between Perimeter Dike and Containment Dike of Cell 1 Undergoing Closure (Looking North from Perimeter Dike)**

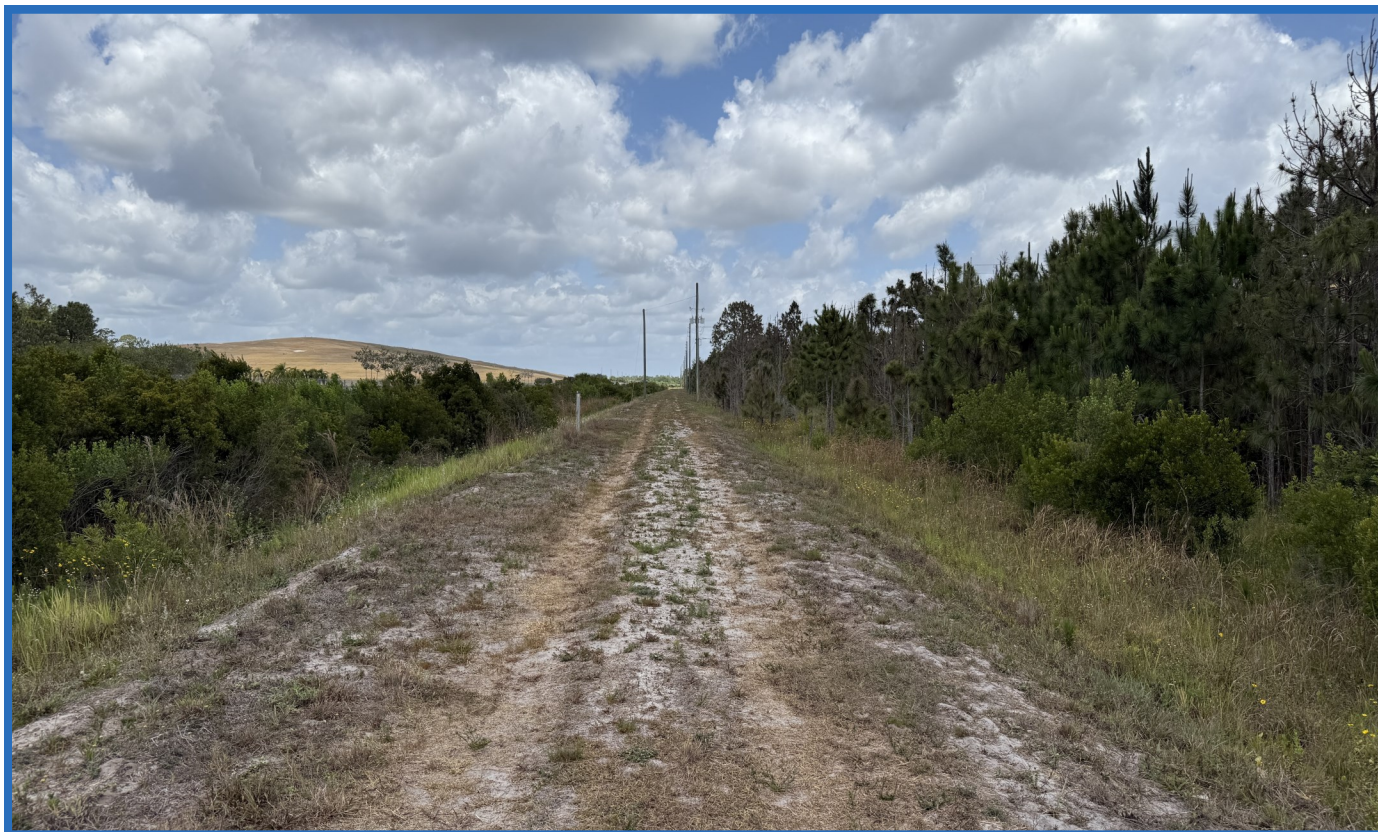
**Monitoring Well MW-9R (Looking North on Toe Road West of Cell 1)**

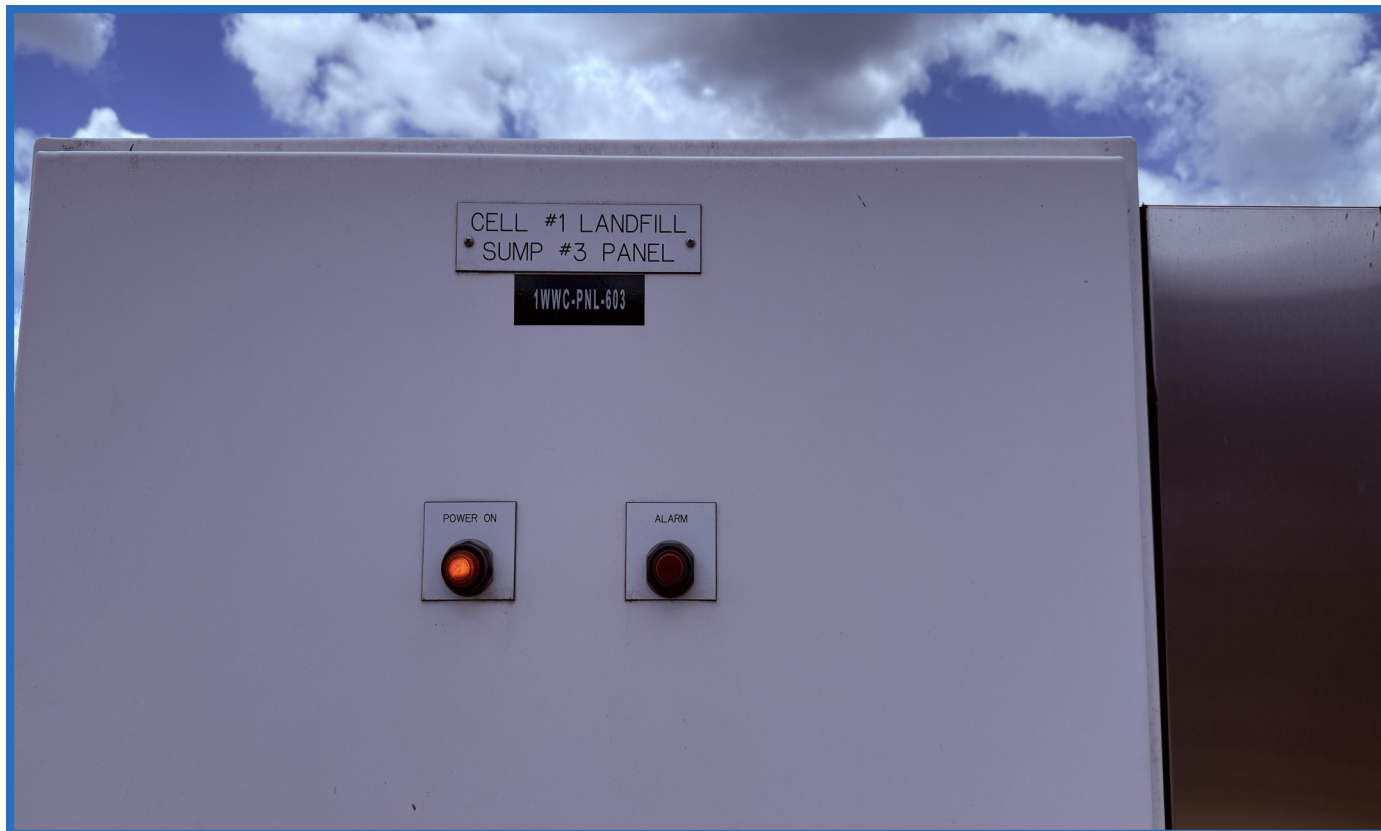
- The panels of leak detection system and leachate collection system pumps at Sump 3 and Sump 4 of Cell 1 showed faulty high water levels during the weekly inspections from September 19, 2024 to November 5, 2024.
- The leak detection system pump at Sump 3 of Cell 2 showed high sump water levels during the weekly inspections from November 12, 2024 to December 30, 2024.
- The leachate collection system pump at Sump 2 of Cell 2 had loss of communication during the weekly inspections from November 12, 2024 to December 30, 2024.
- The leak detection system pump screen at Sump 1 of Cell 2 was not working during the weekly inspections from November 12, 2024 to December 27, 2024.

**Outside of Control Panel Cabinet for Cell 1, Sump 3**

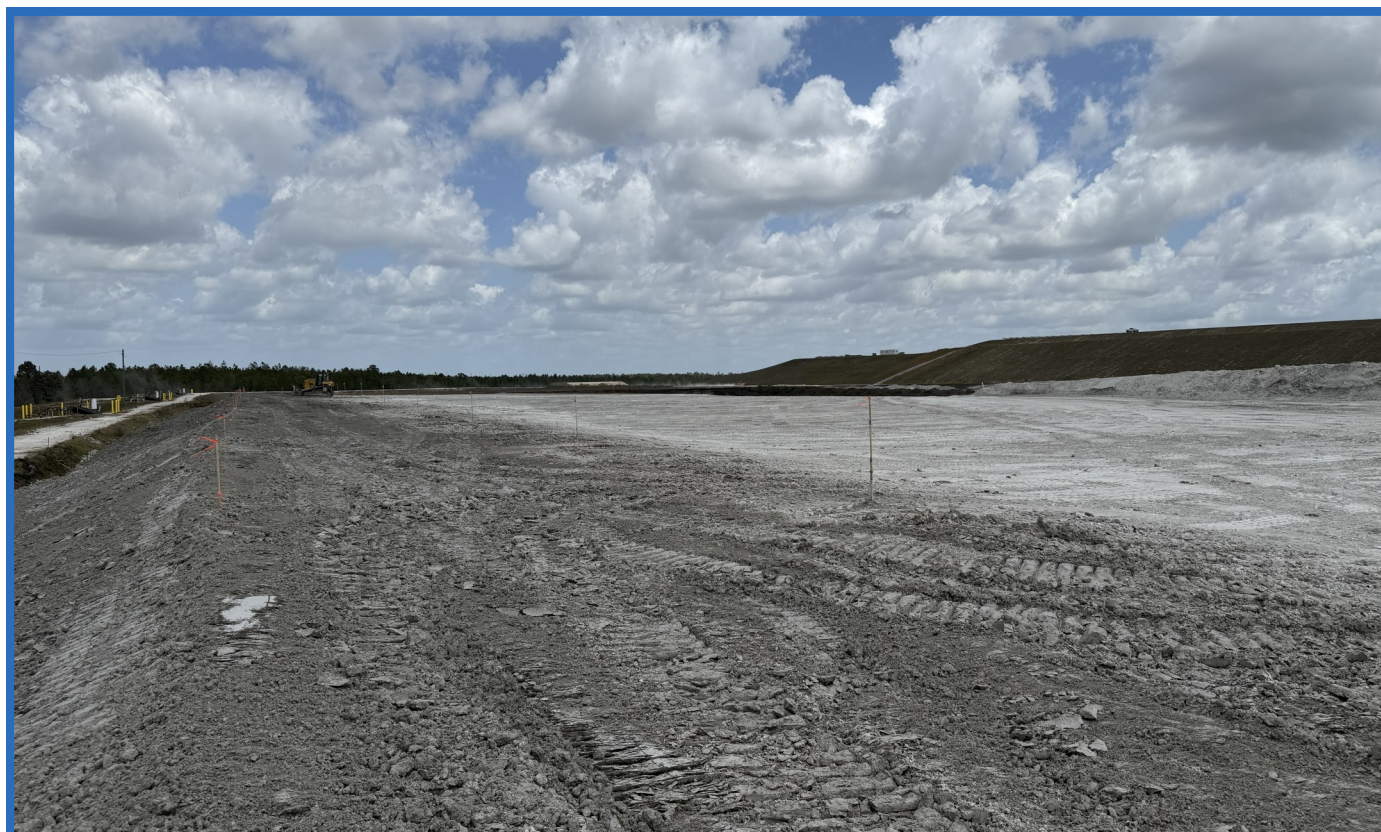
**Waste Placed in Two Southern Sub-cells of Cell 2 (Looking Northeast from Southwest Corner of Bottom of Cell 2)**

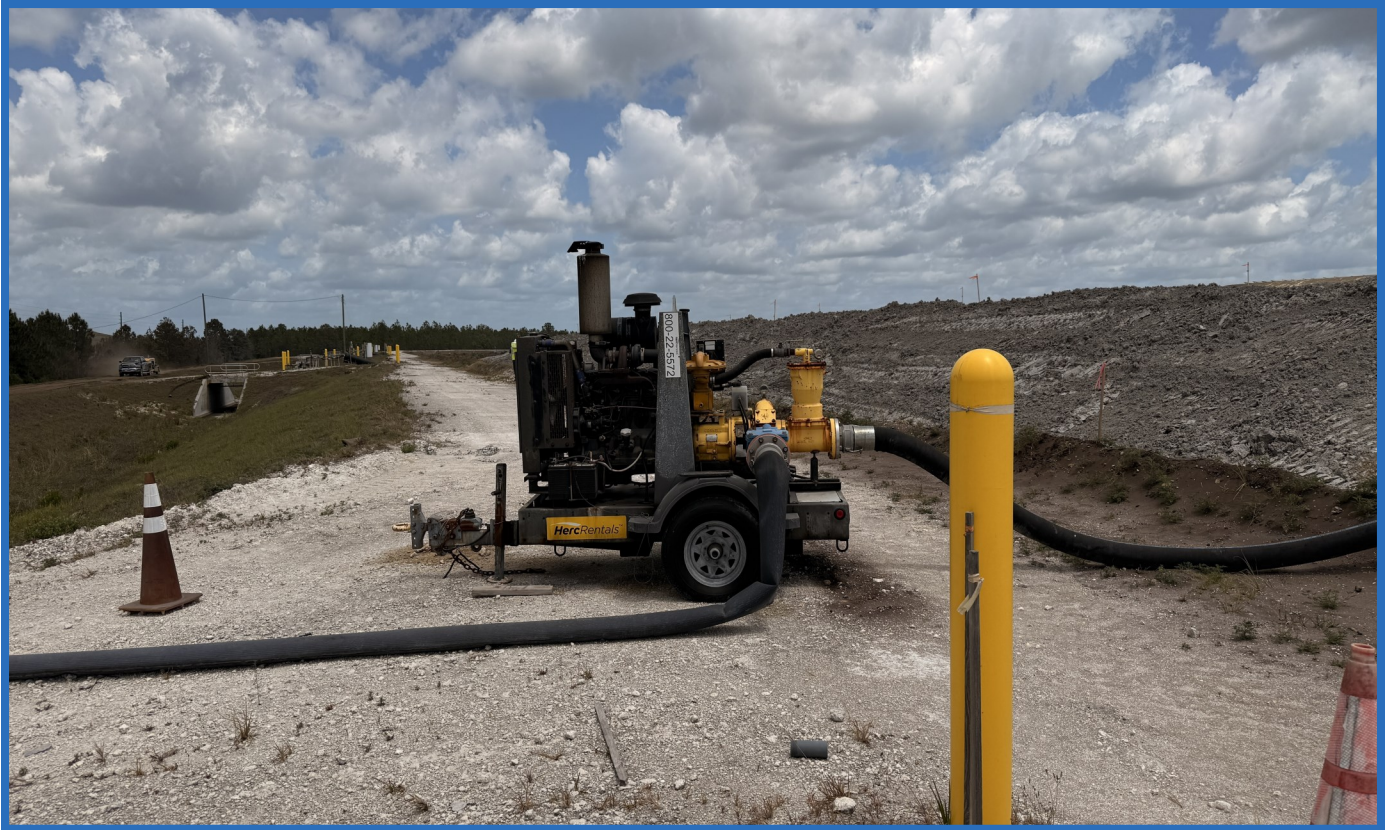
One trailer-mounted auxiliary diesel pump was observed on the crest road of the west containment dike near the southwestern corner of Cell 2, with the pump intake placed on top of the containment dike crest. The auxiliary pump was not operating at the time of our site visit.

**Diesel Auxiliary Pump with Intake Deployed in Cell 2, Sub-cell A (Looking North)**

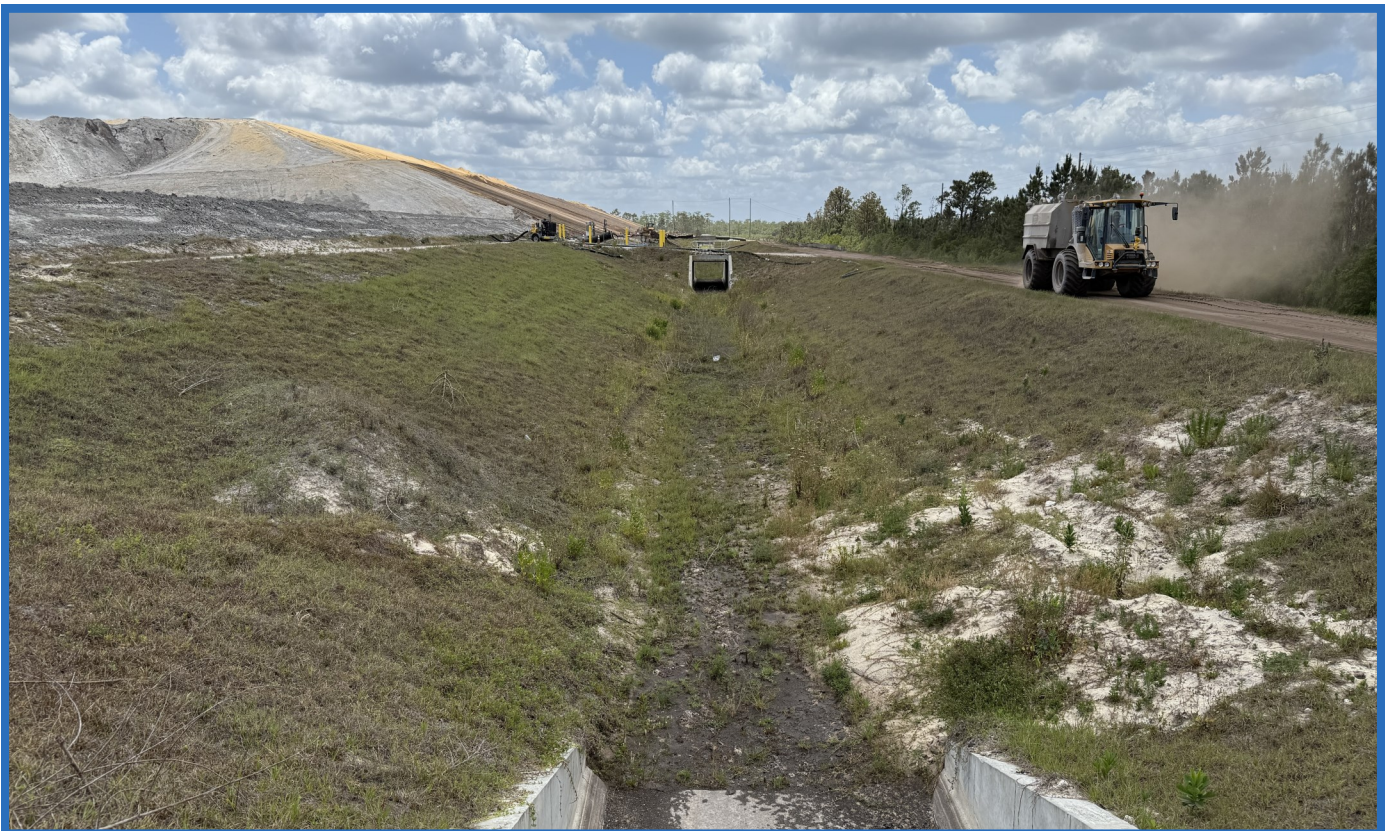
- The box culverts on the stormwater ditch for both Cells 1 and 2 were found to be in good condition except during the weekly inspection of August 9, 2024, where it was noted that the culvert no. 2 for the Cell 2 was filled with soil and needed cleaning. The culvert was found to be in good condition during the subsequent weekly inspection.

**Stormwater Ditch with Box Culverts Between Perimeter Dike and Containment Dike of Cell 2 (Looking South from Perimeter Dike Crossings)**

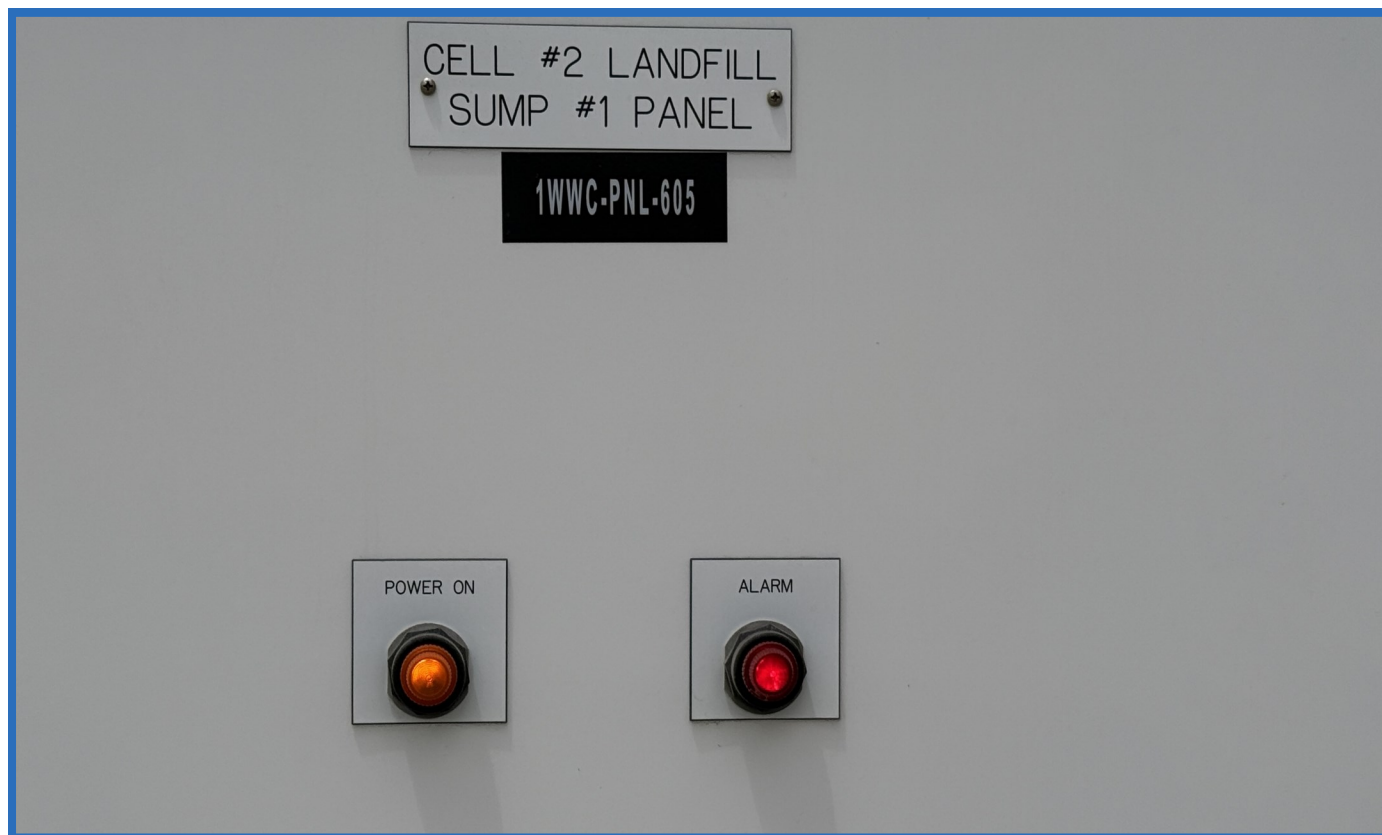
- The leak detection system pump in Sump 1 of Cell 2 did not function during the weekly inspections performed on April 1, 2024.
  - The leak detection system Sumps 3 and 4 of Cell 2 showed high water level during weekly inspections of April 1, 2024.

- The leak detection system pump at Sump 1 of Cell 2 had an alarm going off during the weekly inspections from May 22, 2024 to July 3, 2024 and the pump switched on and off during that period.

Outside of Control Panel Cabinet for Cell 2, Sump 1

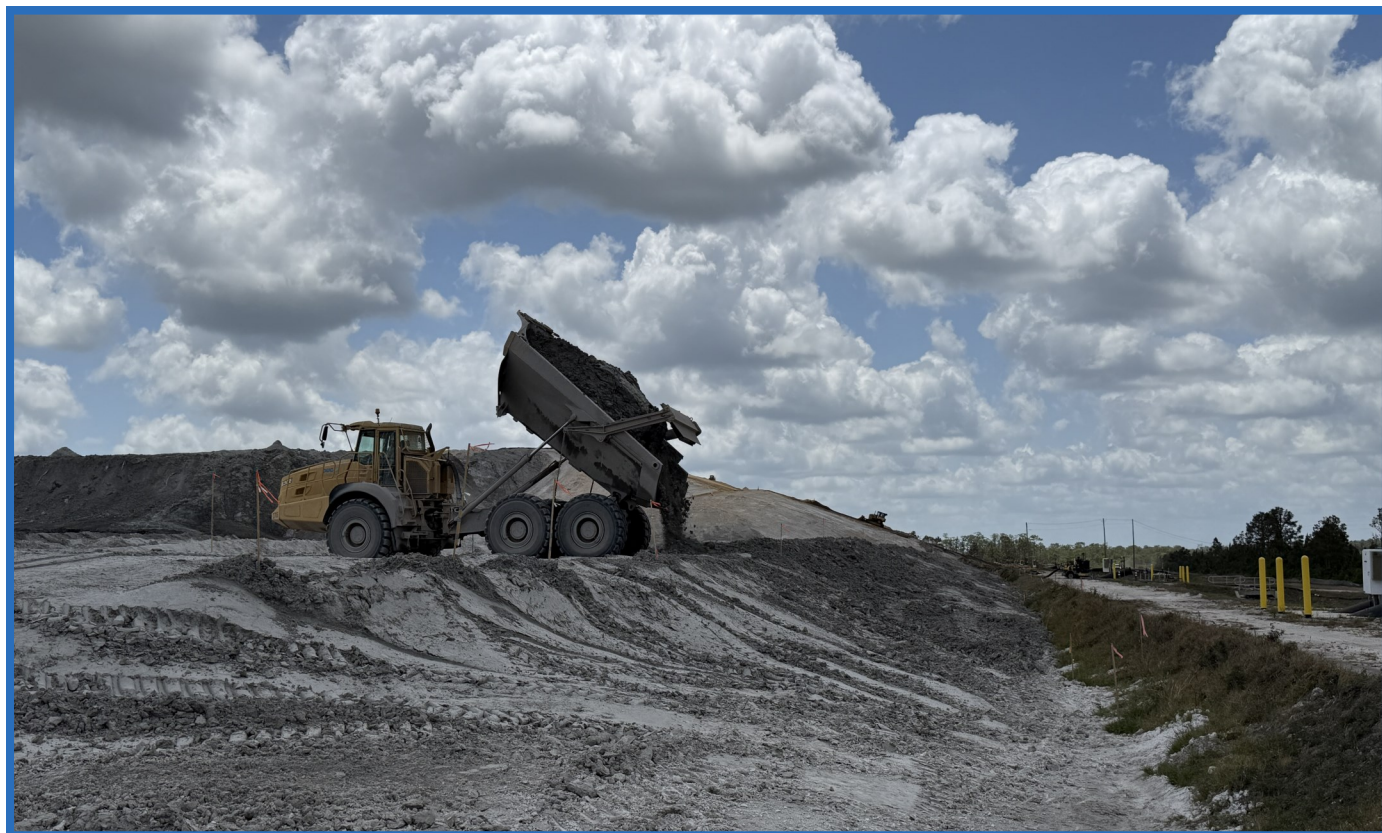
Articulated Dump Truck Placing Waste in Cell 2 (Looking South/Southeast)

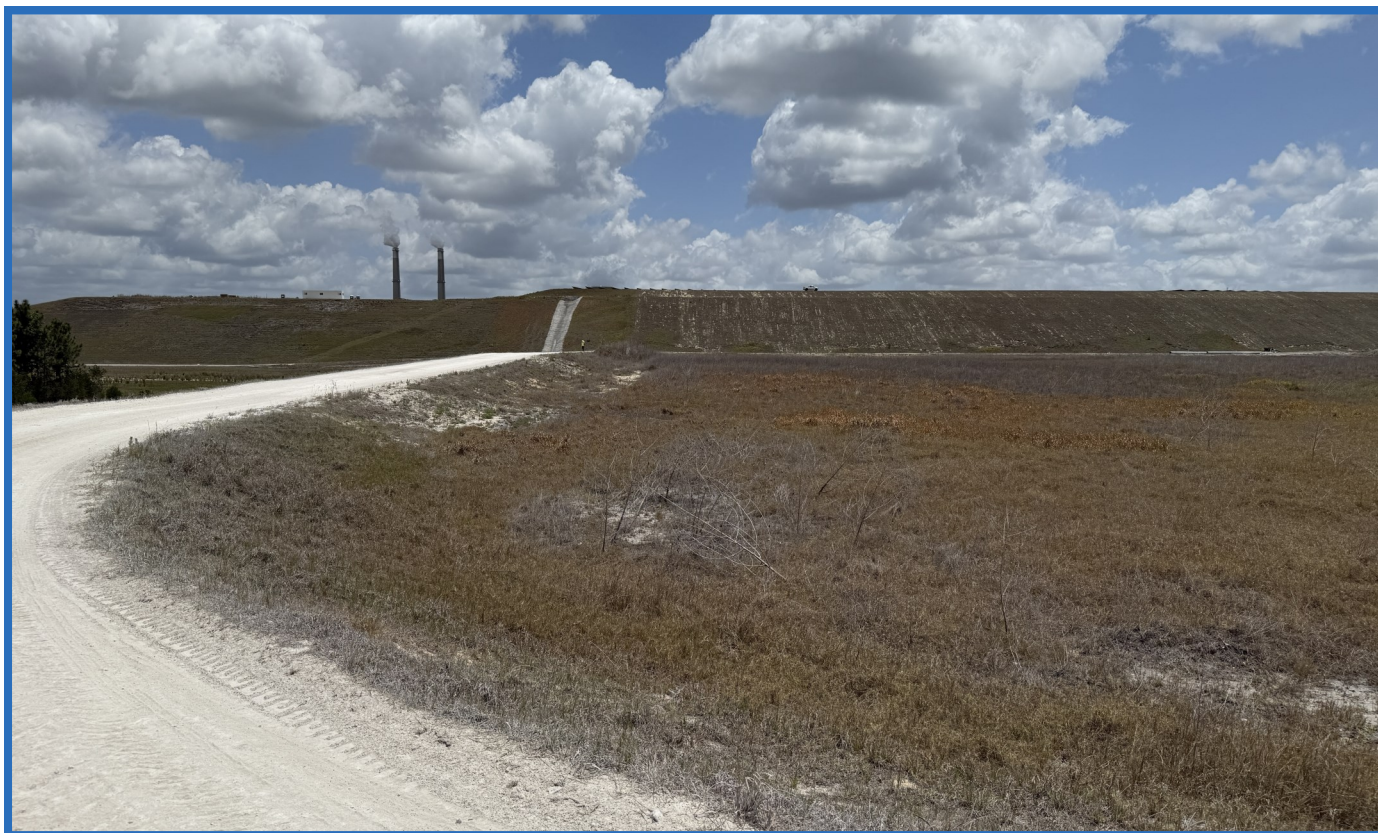
**Containment Dike and Northernmost Sub-Cell of Cell 2 (Looking East)**

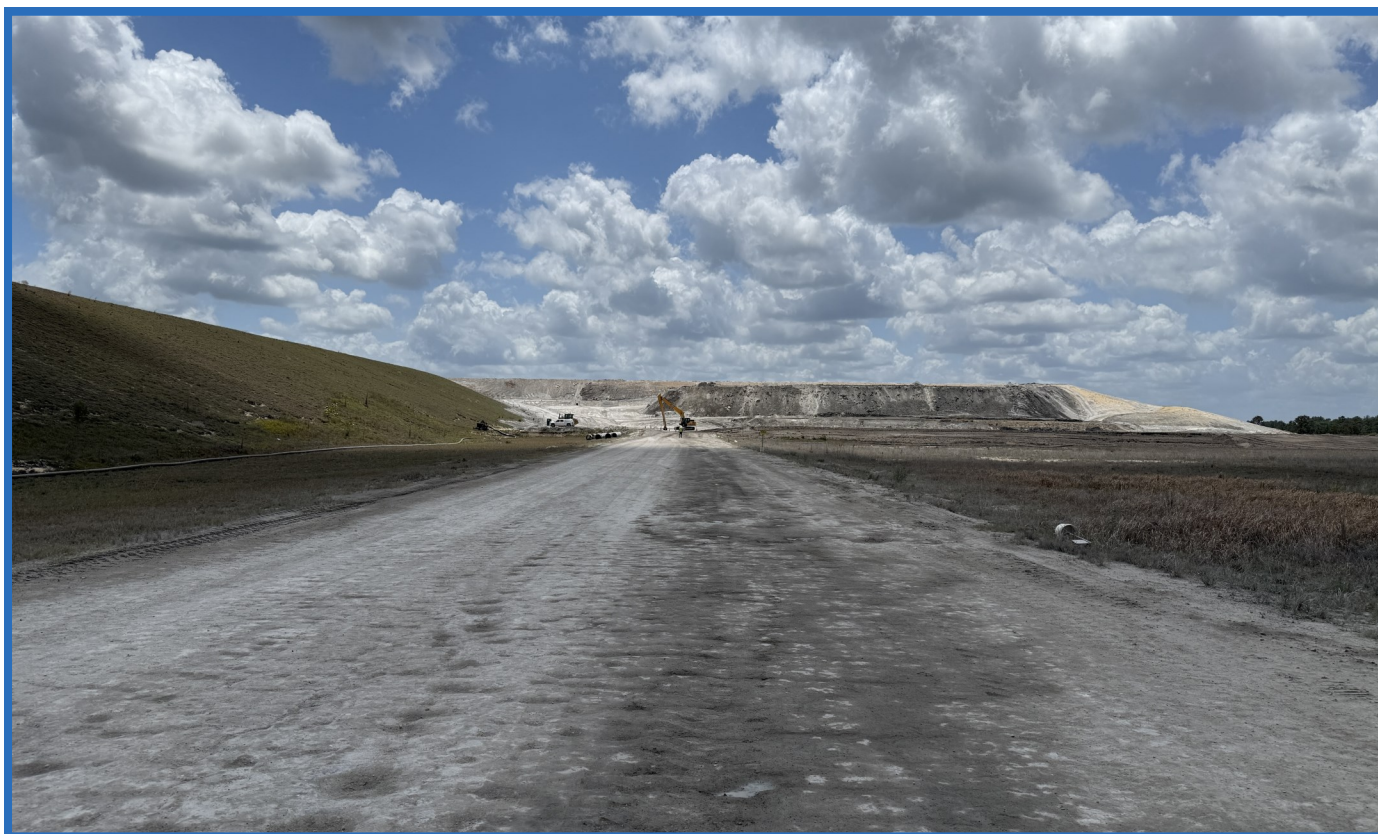
**Access Road through Bottom of Cell 2 (Looking South)**

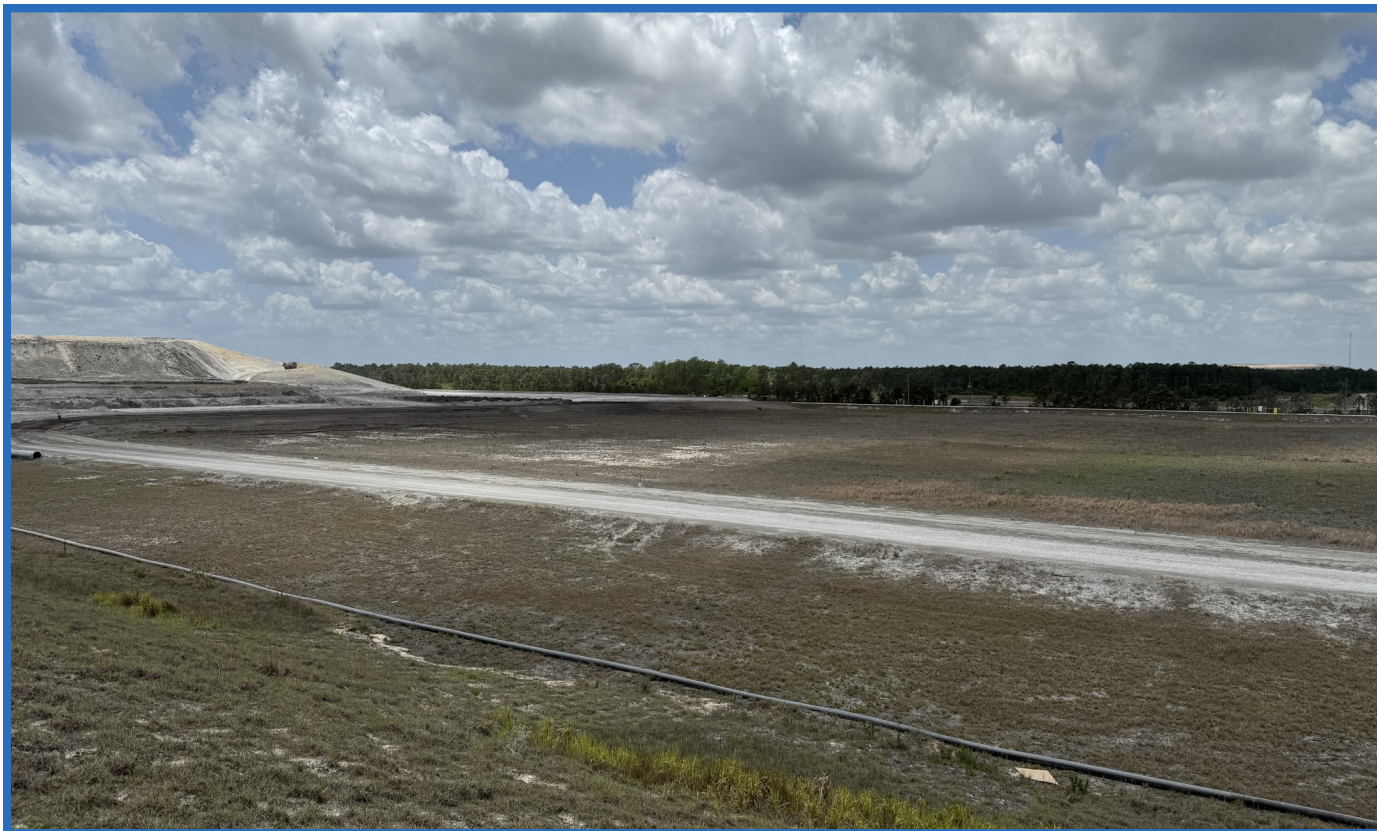
**Two Northern Sub-Cells of Cell 2, Which are not receiving Waste (Looking Southwest from top of the Closed Vertical Expansion of Original CWSA)**

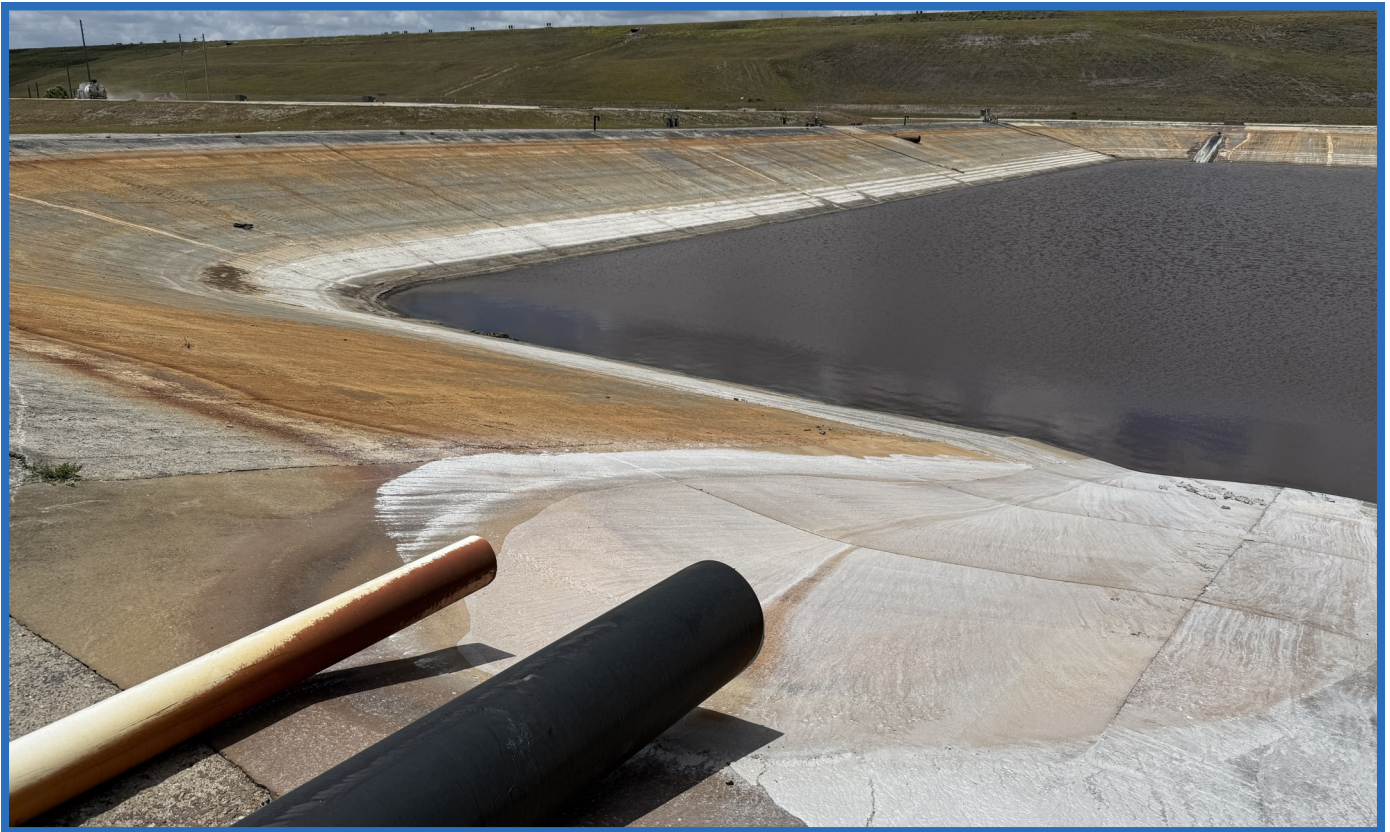
Southern Compartment of CWSA Runoff Pond (Looking Southwest/West)
